# Unexplained Accelerated Corrosion in ULSD Systems

Brussels, March 16, 2011

Fuel Quality Services, Inc.

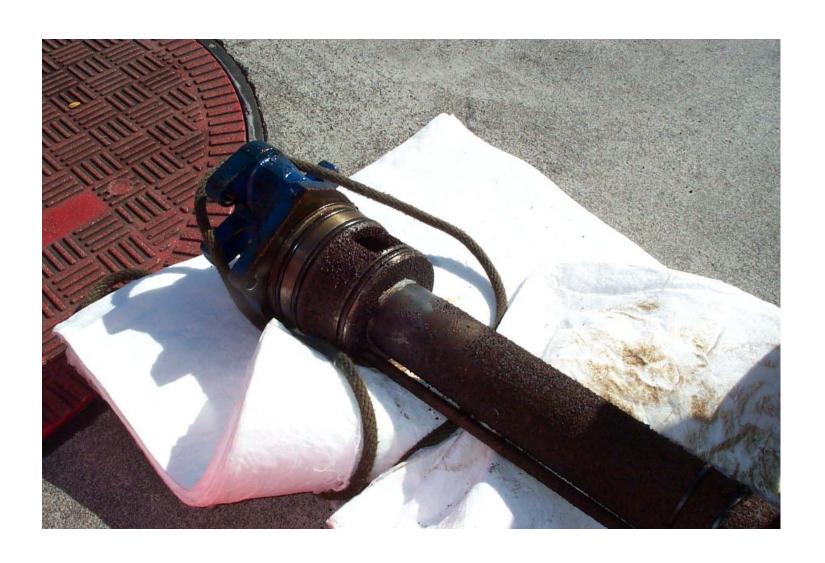
#### ULSD STP Manifold & 4" Riser

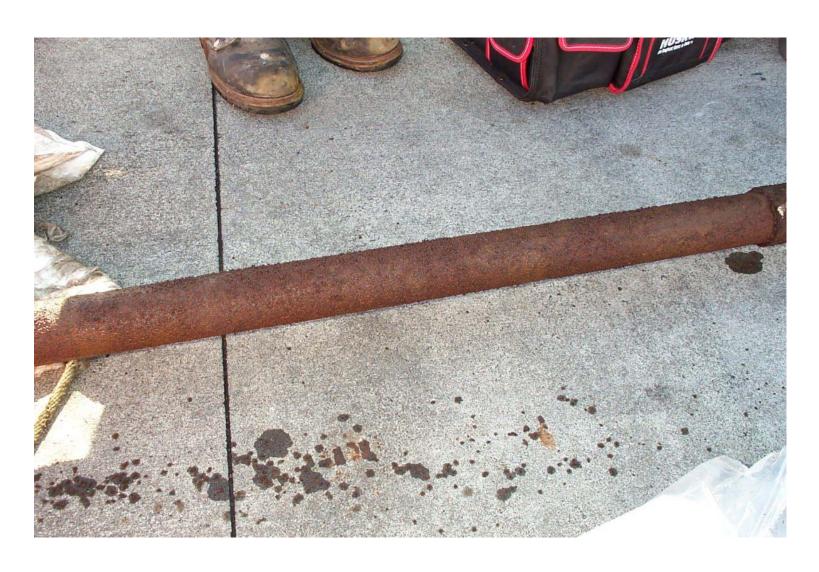
# ULSD Column Pipe

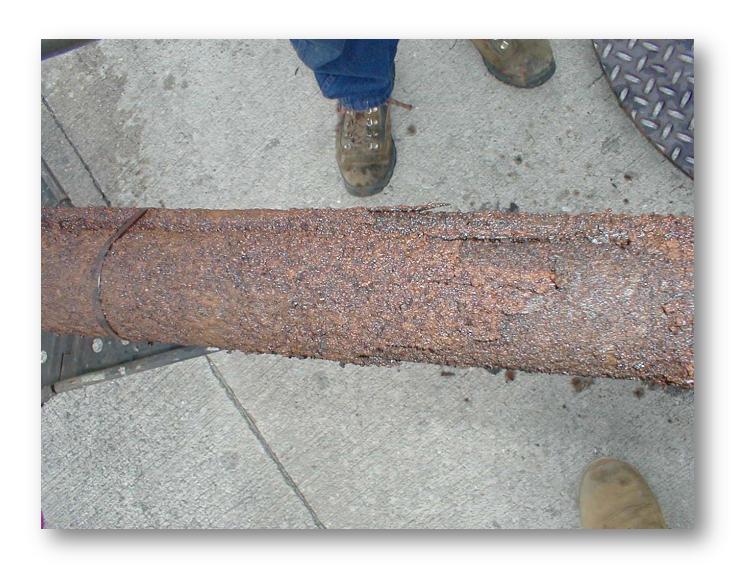
# **ULSD Column Pipe**

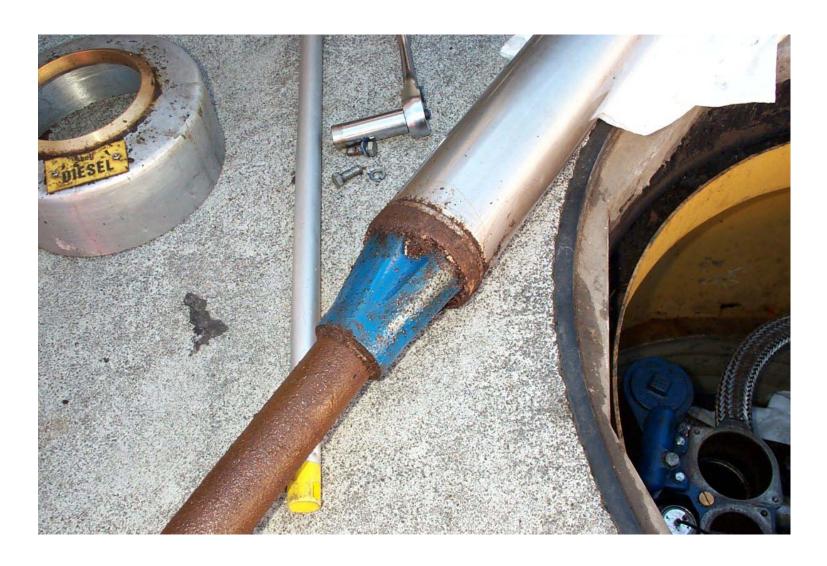
## **ULSD Pump Motor Assembly**

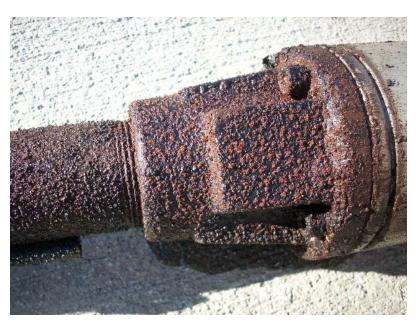
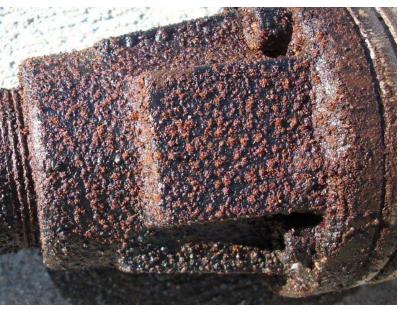
## STP Reducer Fitting

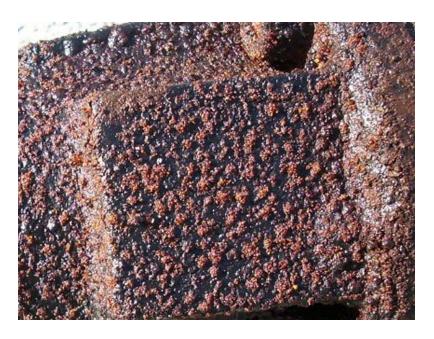
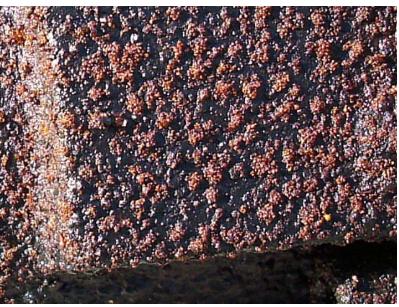
## Close Up of STP Reducer Fitting

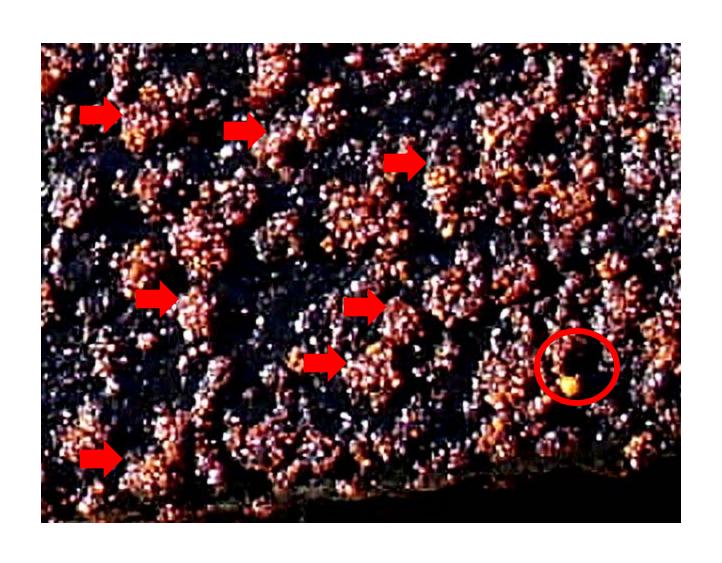
# STP Reducer with Carbuncles and Reduced Sulfur Potential for SRB?

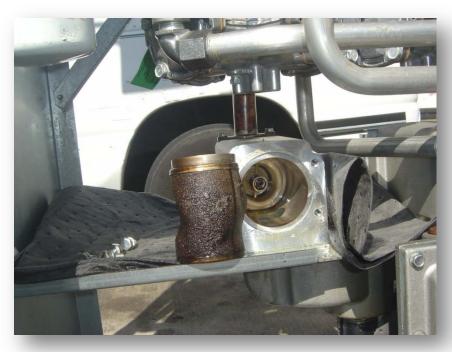
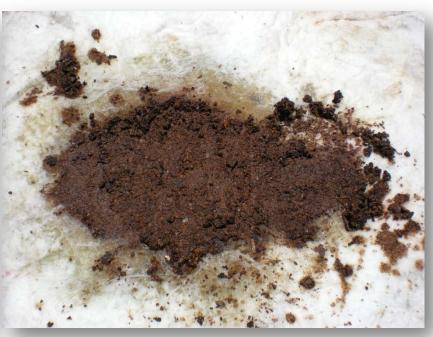
#### **ULSD Corrosion Product**

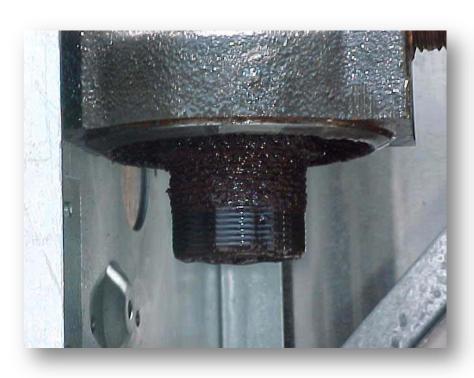
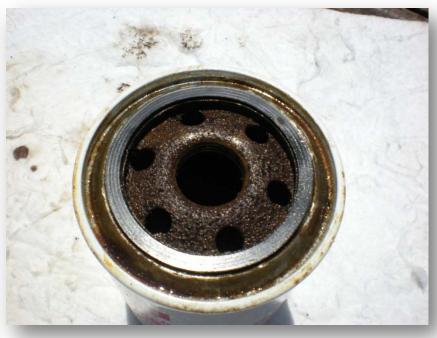
# **ULSD** Dispenser

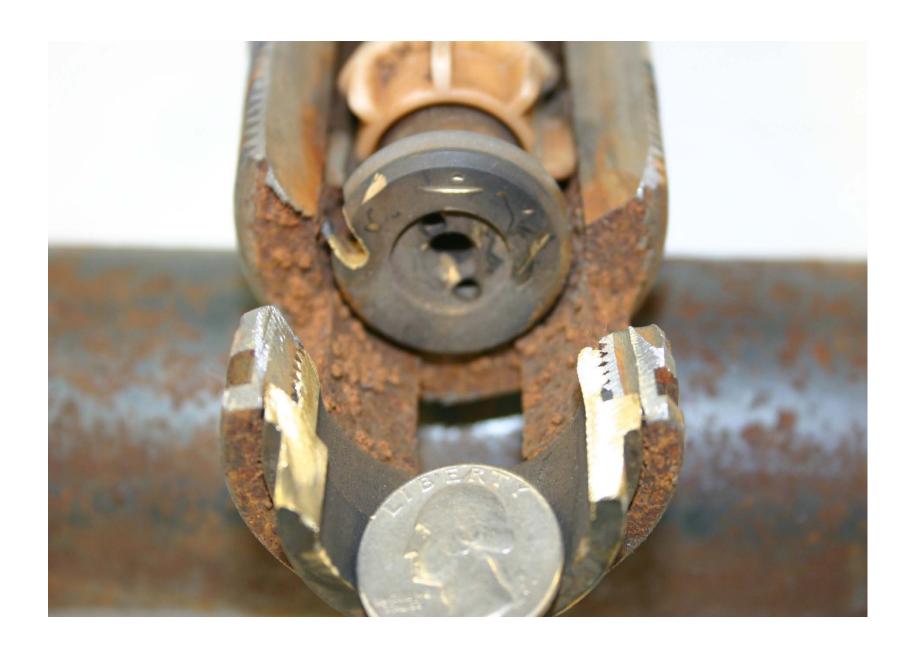
Old vs New

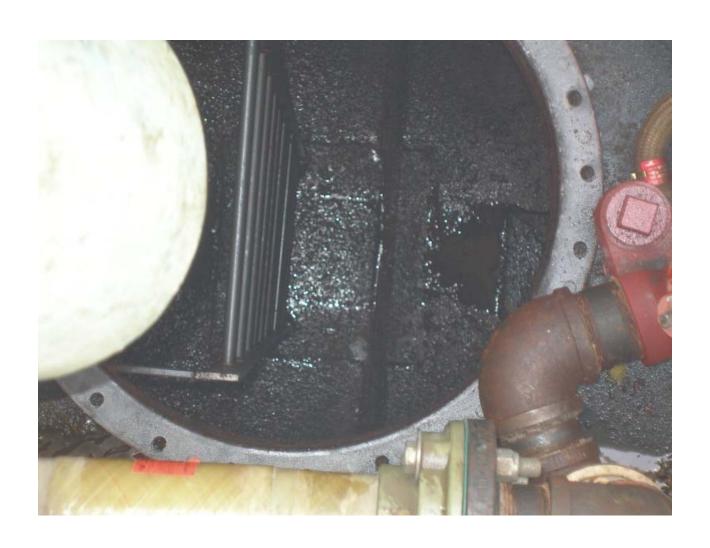
# Black "gunk" in tank

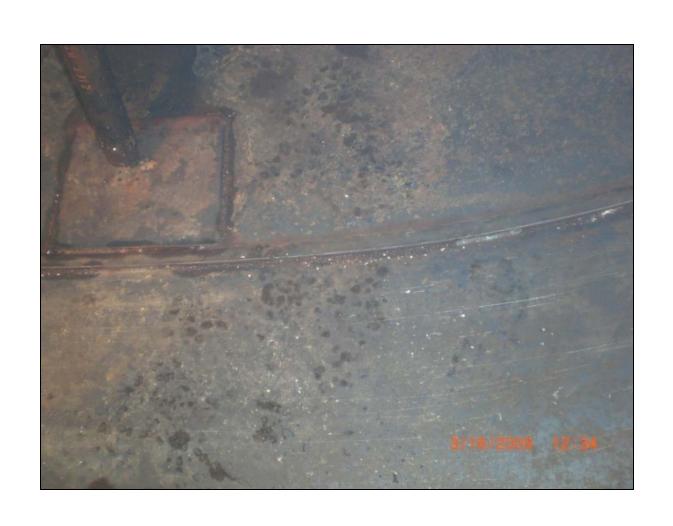
### **Tank Bottom**

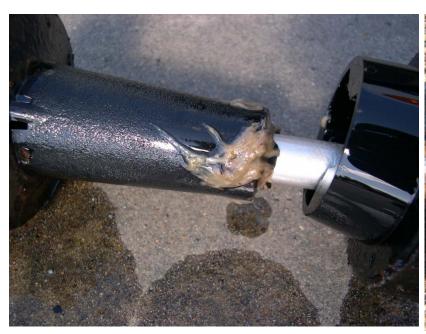
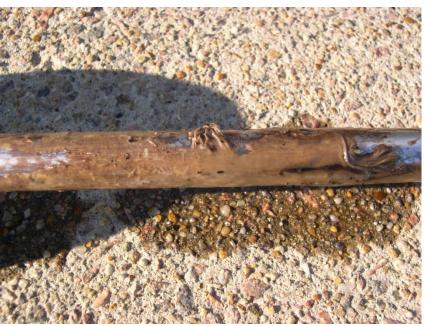
### **ULSD Fuel Tank ATG**

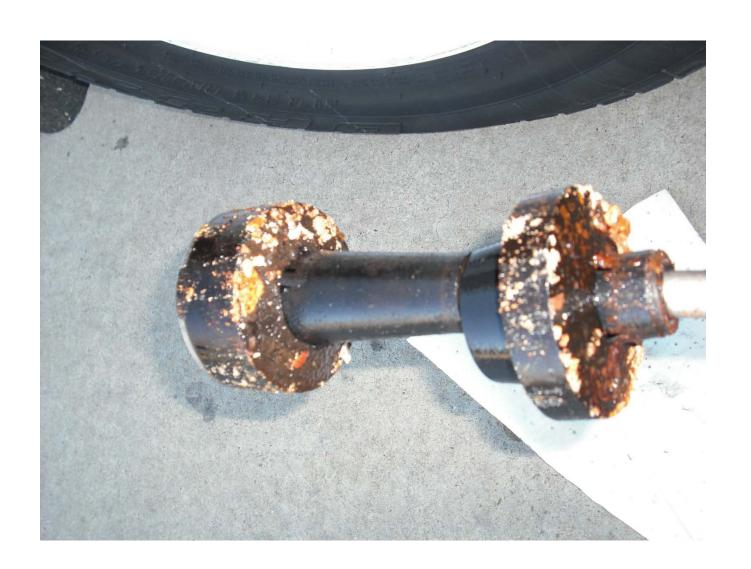
#### **Encrusted ATG**
