COPEX 2014

Pipeline Inspection and Repair – Dents

Case Study UKOP Thames – Mersey Pipeline

Investigation and findings on features identified on 14” pipeline following last in-line inspection

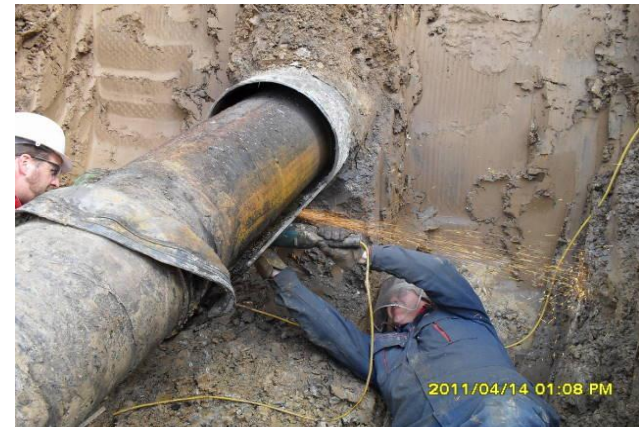
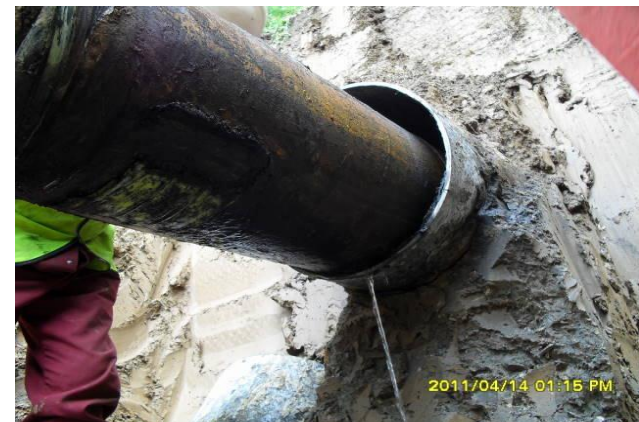
Dent 1

- 1.8% dent/metal loss and shorted sleeve
- Previously reported in 2002 ILI as not a dent but a touching casing
- Pipeline sleeve had crushed spacer and pipe resting on casing
- Dent/metal loss within length covered by sleeve
- Repair works identified to ensure pipeline integrity
- Major road near London

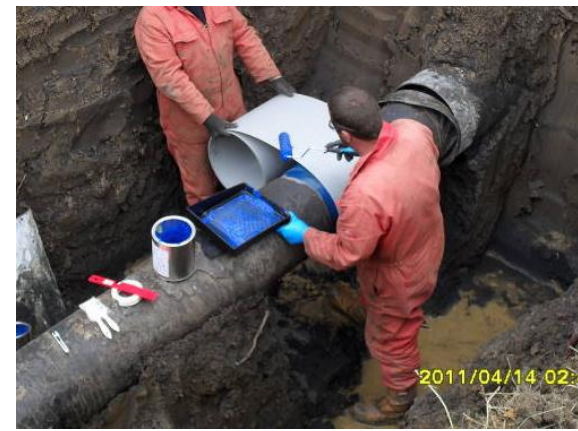
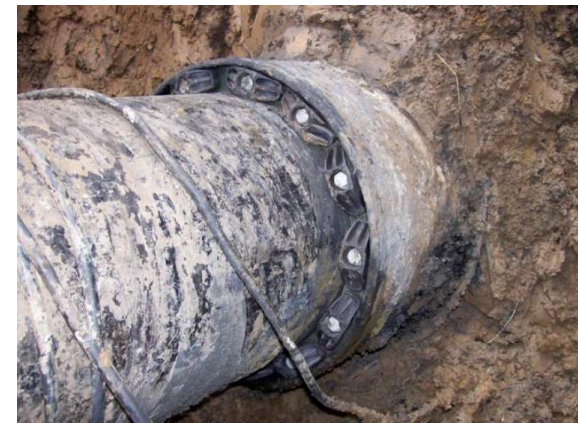
Dent 1

Failure Causes

- Natural ground movement around pipeline

- Wrap master repair on dent
- Casing cut-back and re-aligned
- New link seals installed

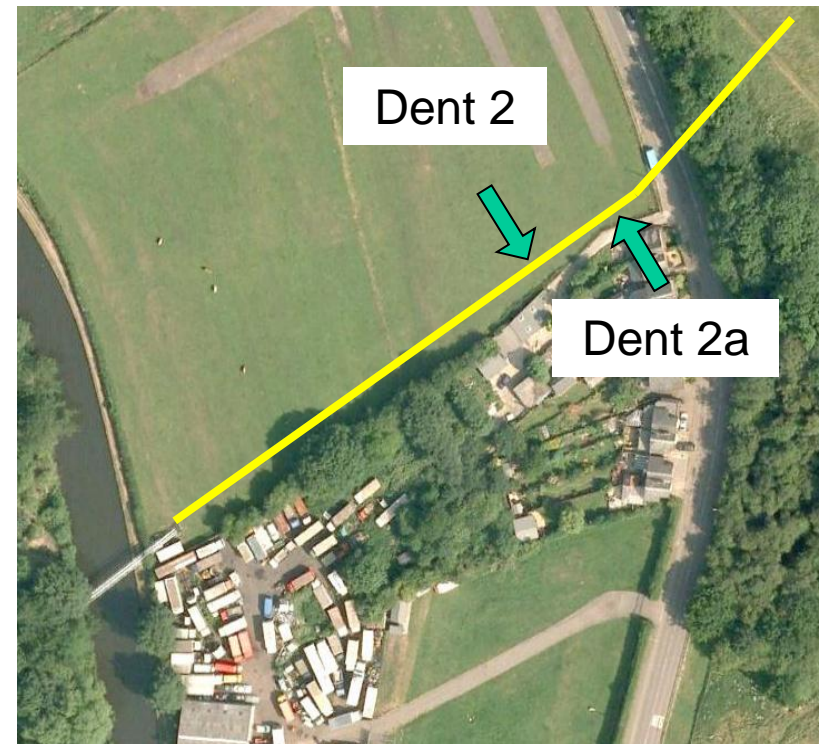
Dents 2 and 2a

- Dent 2: 6% dent with associated metal loss
- Dent 2a: adjacent to Dent 2
- Previously reported in 2002 as exaggerated reaction of sensors to girth weld and no metal loss
- Dents excavated and repair strategy developed
- Pipeline Clamps installed as temporary measure
- Local land use issues also had to be taken into account

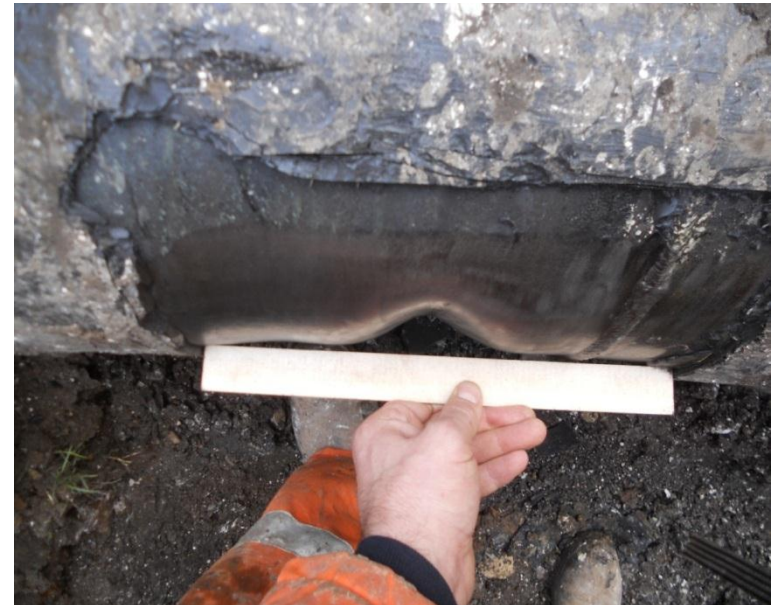
Dent 2

Failure Cause

- Construction/installation damage
- Believed to have been there 45 years

- Cut out and replace repair strategy
- Pipeline nitrogen cleared
- Pup pieces installed
- 2a pup piece had to be formed
