## **Characterization and assessment of laminations**

CONCAWE - OPMG

Brussels - April 2014

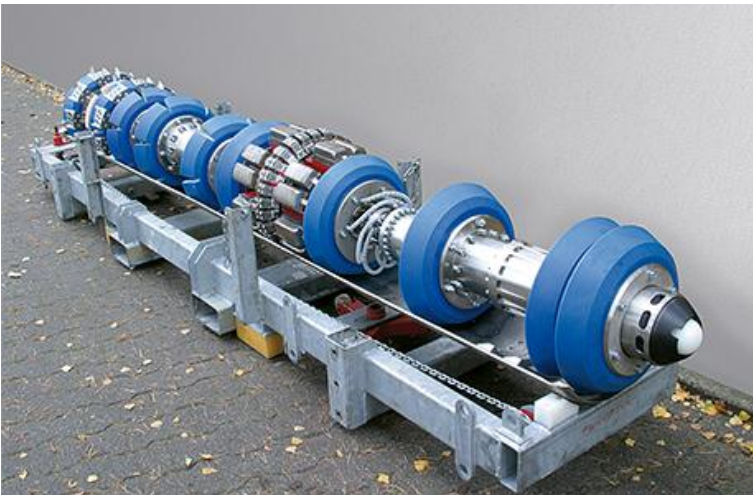
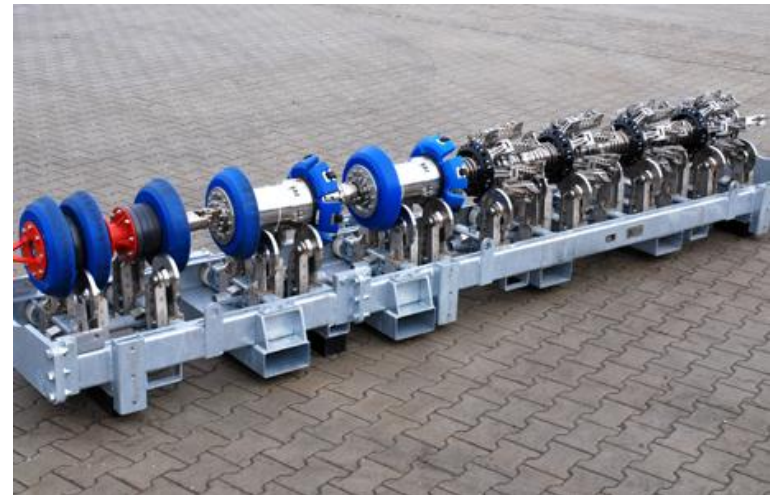
- 5 year inspection program:
  - 4,000 km of pipelines inspected every 5 years.
  - CLH performed in 2009-2010 UT and MFL+UT inspection.
  - CLH used UT on 860 km of pipeline and UT+MFL on 350 km.
- During 2009-2010 a large amount of detected laminations wouldn't pass API579 and would require to be repaired. Field reports verified their characterization.

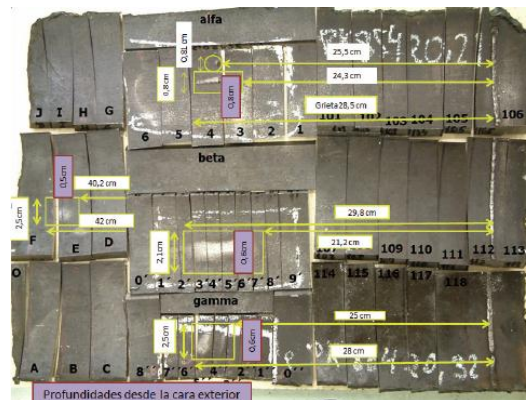
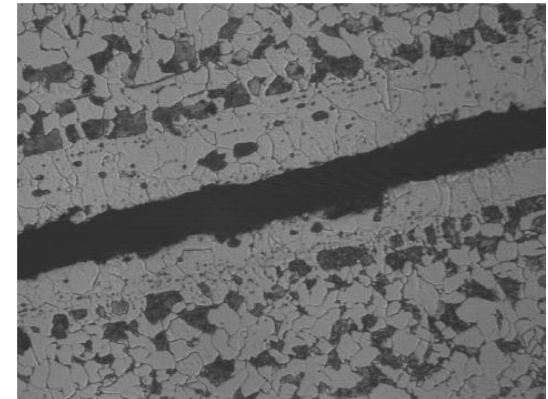
Most severe reported laminations (13) were deeply examined by destructive and non-destructive tests.

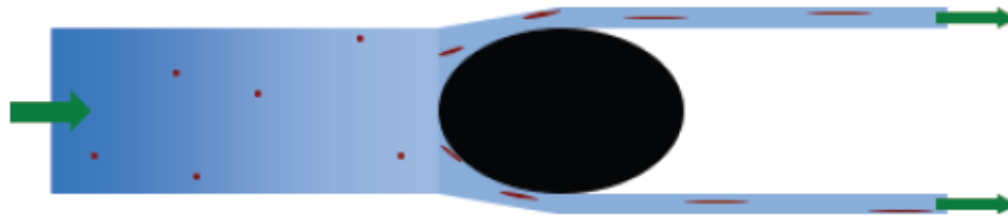
1- All of them were parallel and associated with non-metallic inclusions during manufacturing.

2- No inclined laminations were found. They were several laminations parallel to the wall on different heights.

3- Laminations are always associated with manganese sulfur (non-metallic) and do not propagate beyond those inclusions.

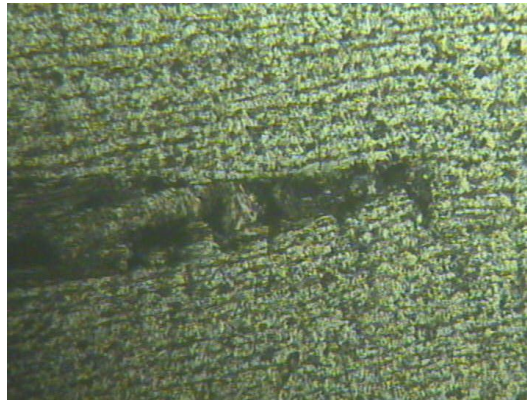
4- Laminations have a certain width but are not classified as cracks, the limits of the lamination had a carved like shape.

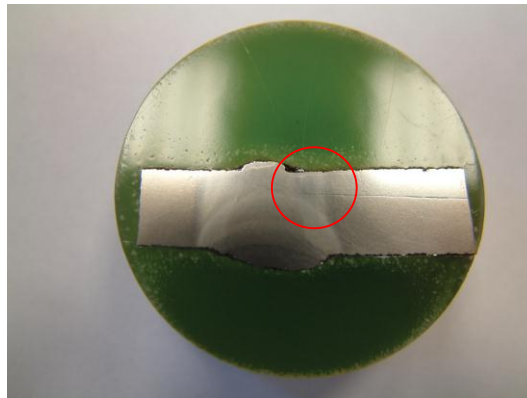
5- Laminations near to girth welds show no deviation in plane laminations.
