COPEX, 2014, Brussels ILI and CP Data Comparison and Usage

David Eyre, Penspen, UK

3rd April, 2014

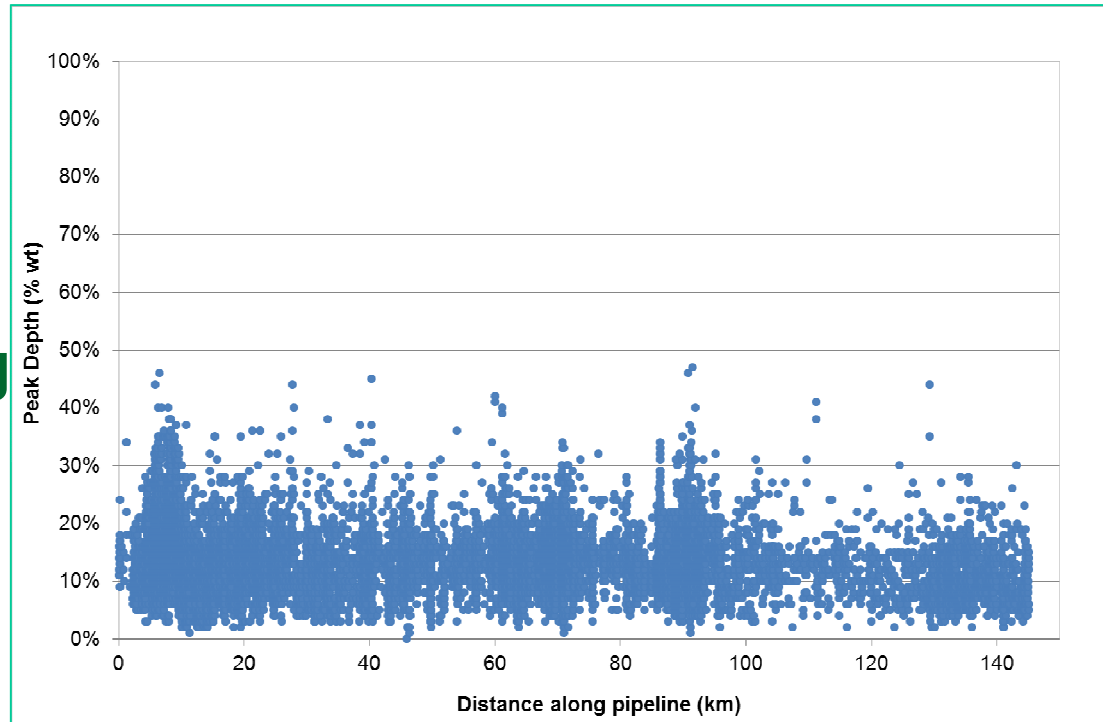
Corrosion along full length of pipeline

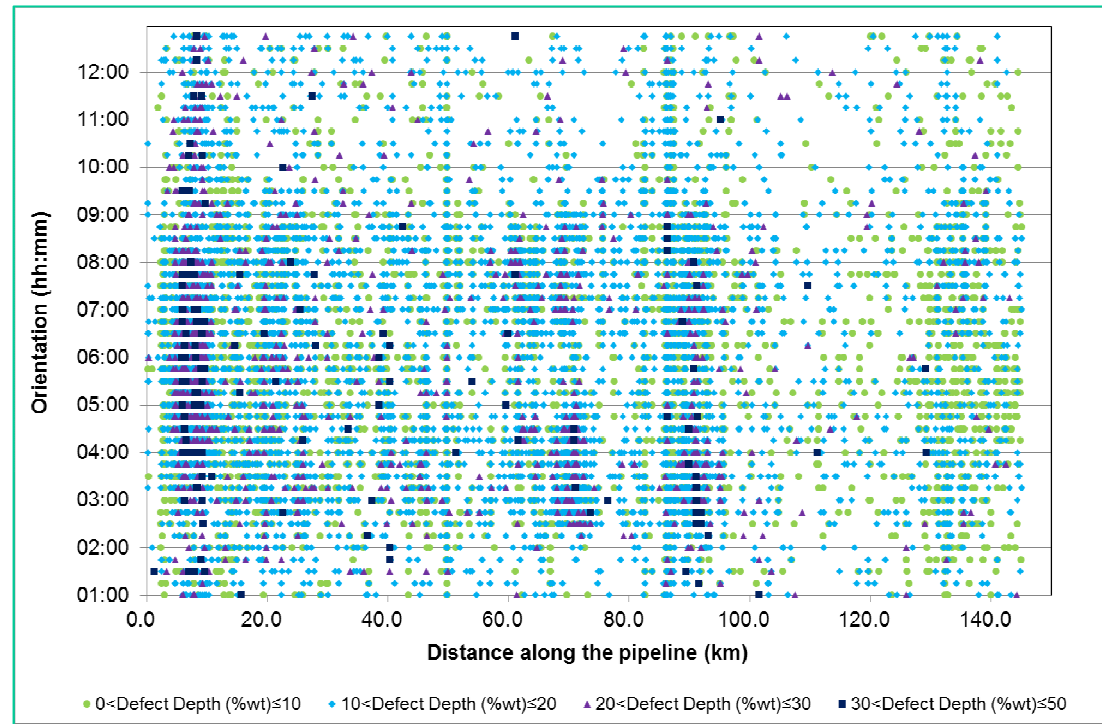
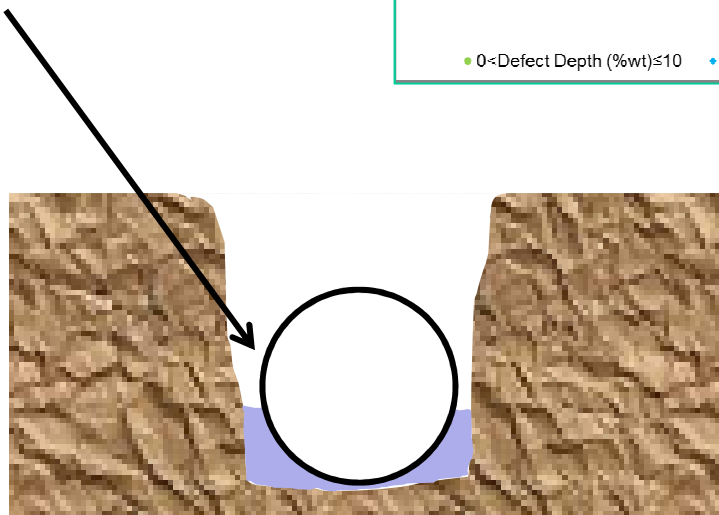
ILI Data Orientation

- Corrosion around full circumference
- Higher rate in lower half
- Wetter in lower half

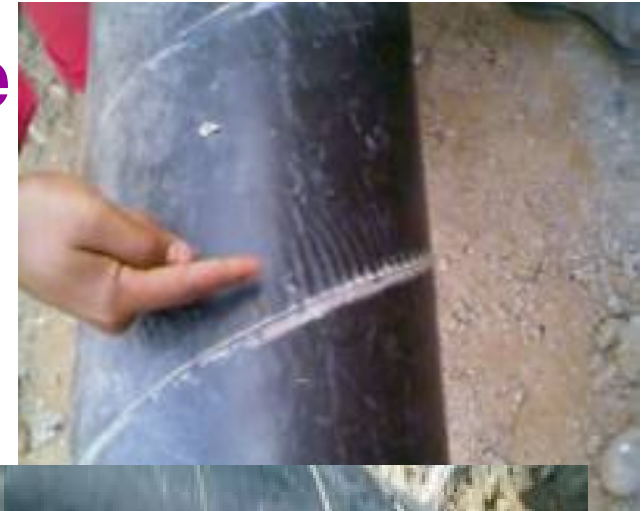
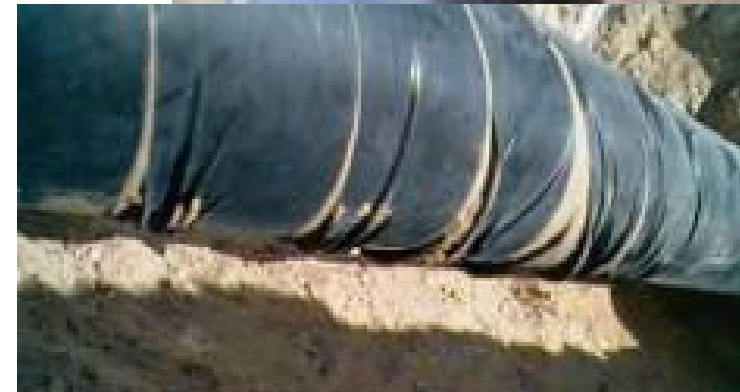
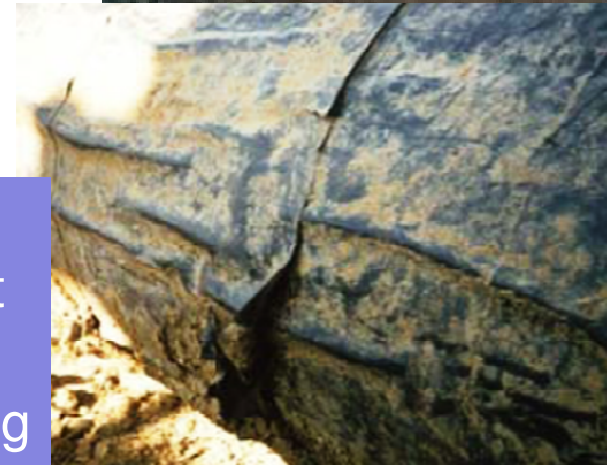
Tape Coating Failure Mode

- Early type PE butyl rubber tape
- Poor adhesion at the overlap
- Soil stresses cause wrinkling and sagging
- Moisture ingress around full circumference

- Verification digs to confirm assessment
- CIPS survey to better assess CP
- CP will always struggle due to shielding

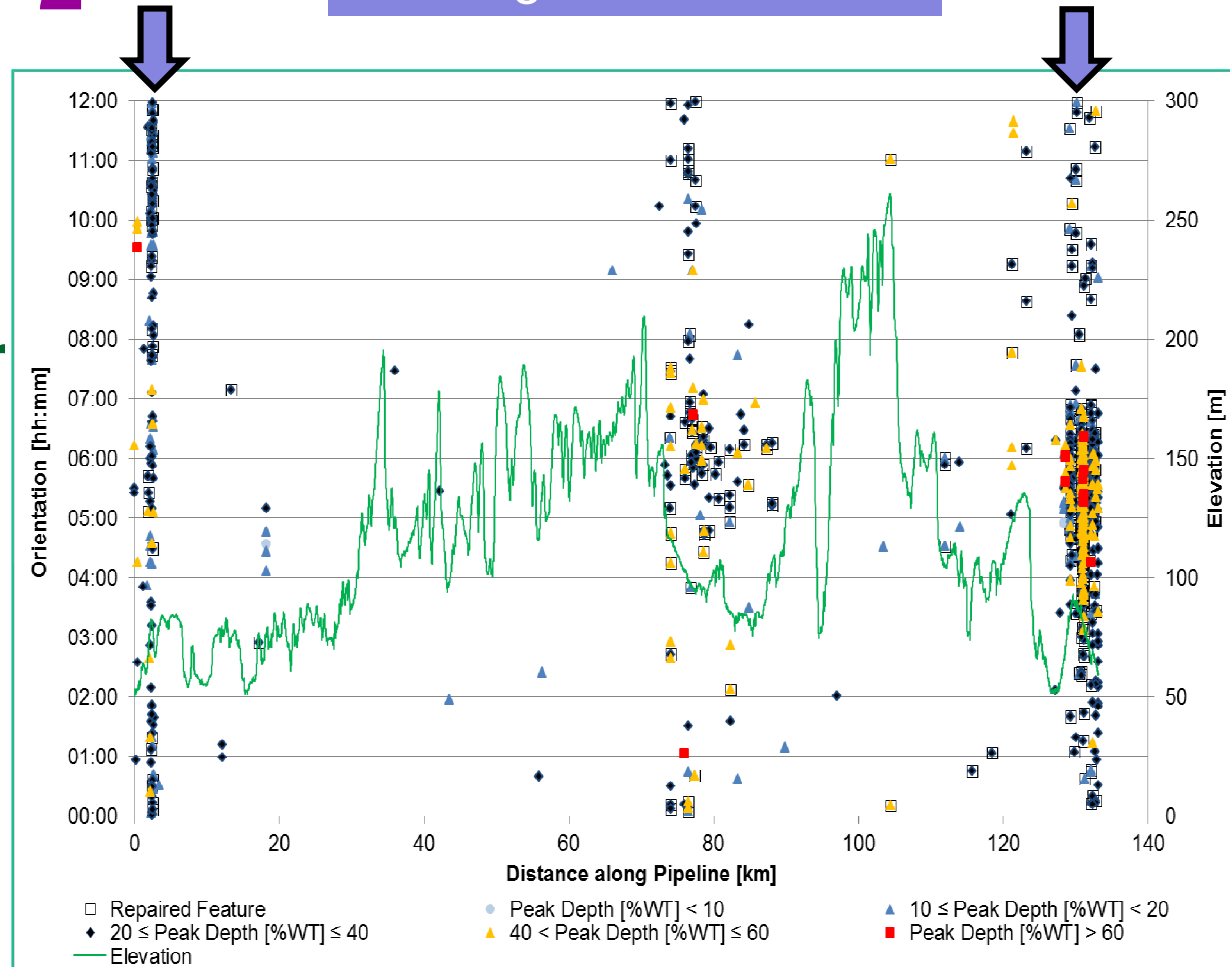
Above ground sections

- Corrosion under pipe supports where access is not easy.
- Corrosion rate 0.12 – 0.38 mm/yr
- Typical corrosion rate under pipe supports in coastal environment.
- Water and soluble salts can be retained in the crevice between the pipe and support.

- Move and recoat under pipe supports
- Verification digs
- CIP Survey needed
- CP needs adjustment
- OFF potentials should be routine

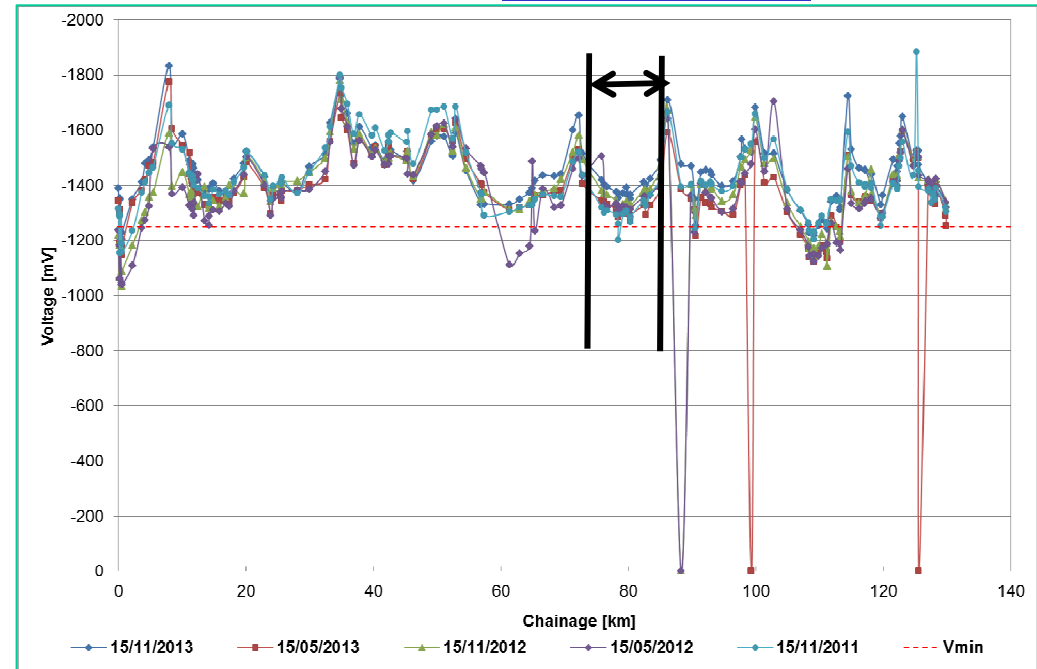
Below Ground Sections

Area of corrosion anomalies

- Corrosion rate low 0.04 -0.07mm/yr
- Only ON potential data available
- Look OK but misleading.
- Corresponds with low elevation on pipeline with chalk high points either side
- Between CP stations

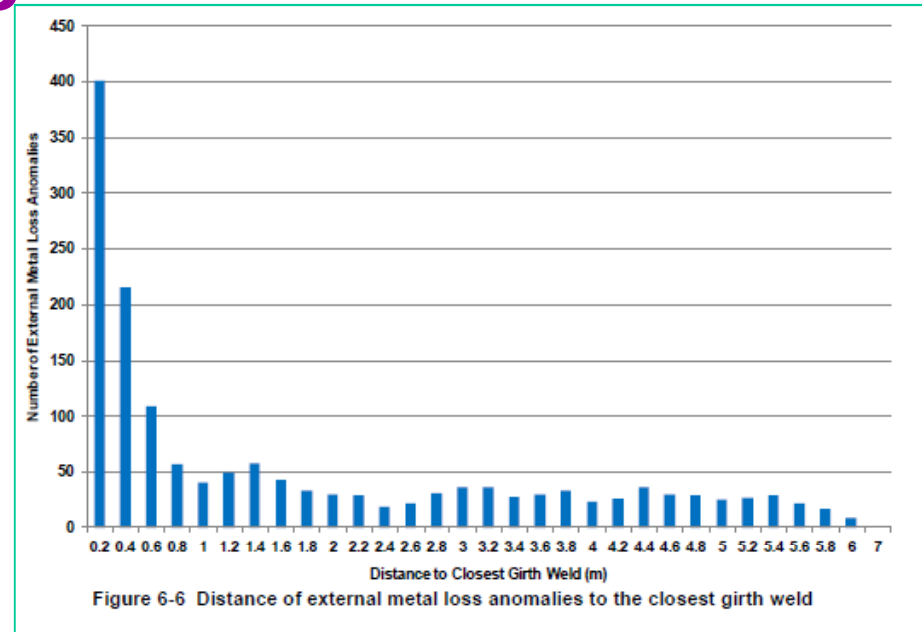
Field Joint Coating

- Concentration of external corrosion features at field joints
- Field joint coated hand applied hot enamel
- Still significant number of defects elsewhere

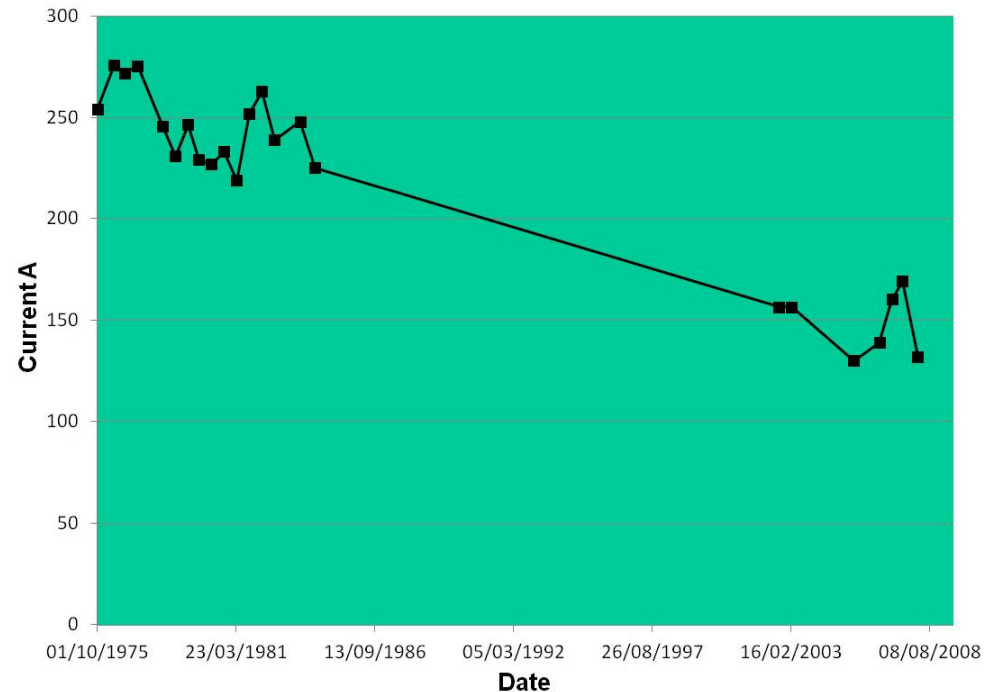
Cathodic Protection - History

- Limited data available
- CP Station outputs reviewed
- Outputs declined over year due to aging groundbeds and misinformed adjustment

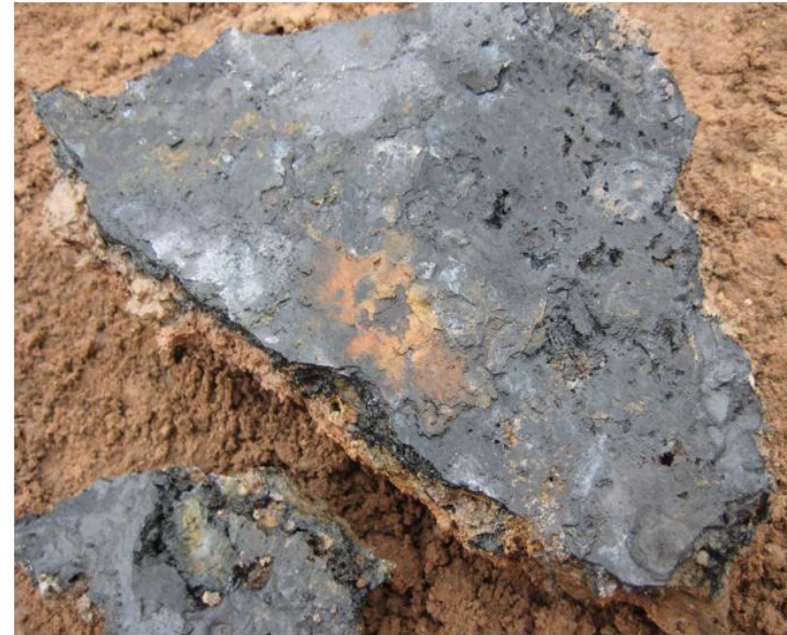
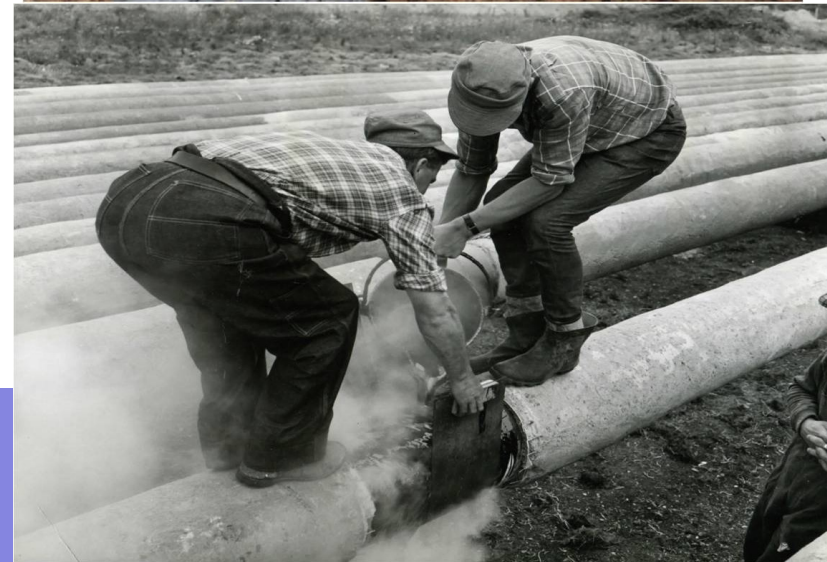
Case Study 3

- Verification digs found coating contained coke particles
- Coke forms a galvanic couple with the steel causing high corrosion rates
- -850 mV not enough
- -950 mV not enough

- Coating coked during application
- Potential criterion used inappropriate
- Restoration of CP Station current capacity ++ a priority
