Ground conditions above cross country pipelines change, reducing protection to the pipeline

MANAGING PIPELINES WITH REDUCED DEPTH OF COVER

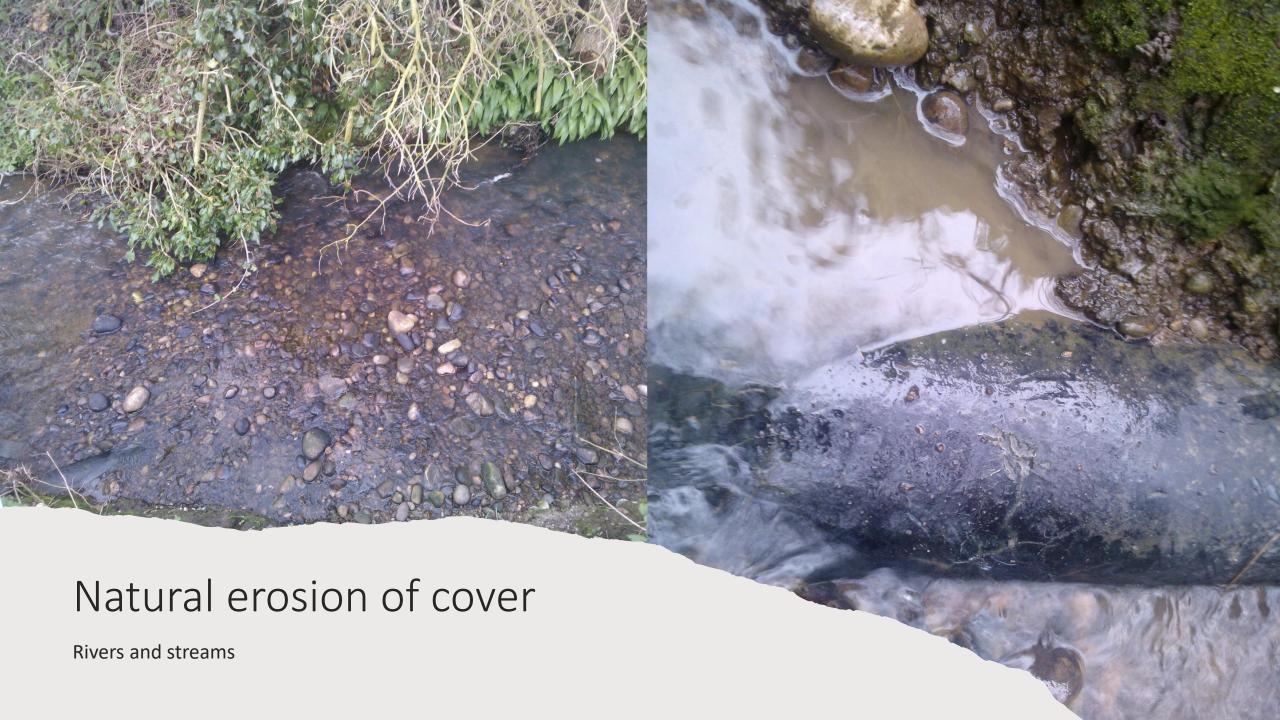
Agricultural drainage ditch maintenance is significant in Depth of Cover reduction over BPA pipelines

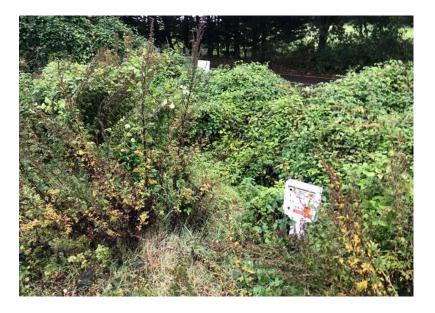
Before

2020 Activity – Location 204 shallow pipe

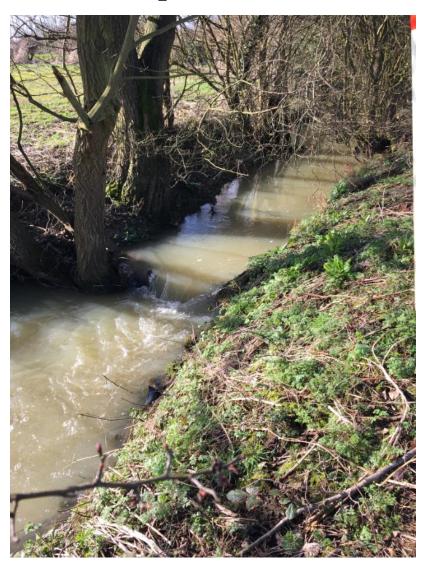
Depth: 100mm

• Length of Issue: 5 metres

Use – Designated River

Possible permanent solutions

Culvert - Not permitted by EA

Concrete slab – Not sufficient depth

Encasing – would create blockage

Concrete canvas – limited physical protection from machine

Diversion – Costly

Compromise – Fencing & Continued monitoring and liaison
