UKOPA United Kingdom Onshore Pipeline Operators' Association

Mechanical and fatigue properties of Pre-1972 Girth welds

Presenter: Tim Rudd (Valero)

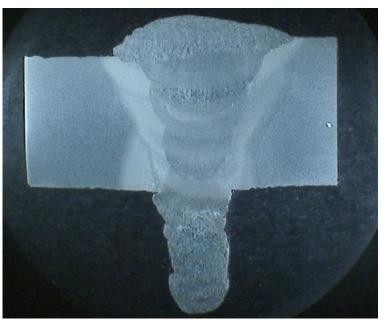
Excess Penetration

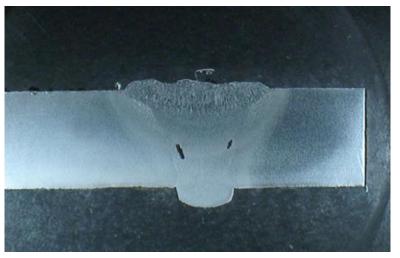
Excess Penetration, Oxide Inclusions/Porosity

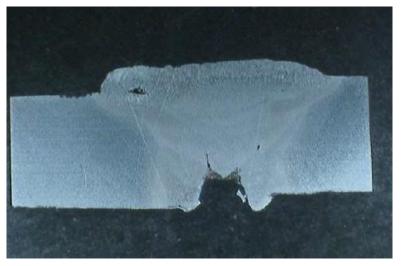
Porosity, Lack of Penetration, Lack of Fusion

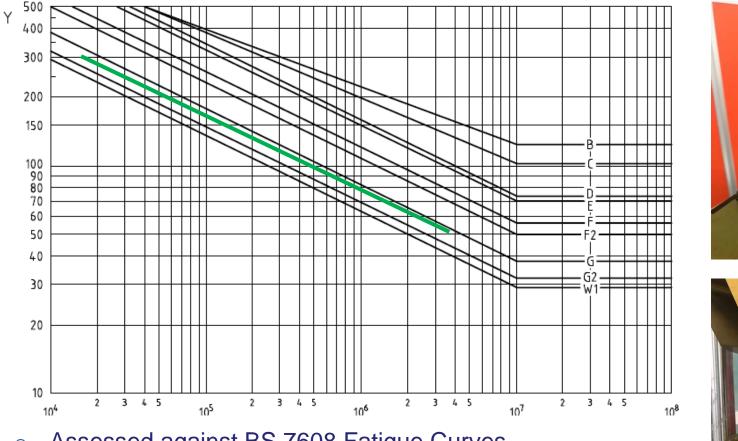
Fatigue Testing

Assessed against BS 7608 Fatigue Curves

- o 'E' curve for welds of known good quality (Strathclyde)
- F2 curve for welds of un-known quality (Swansea)

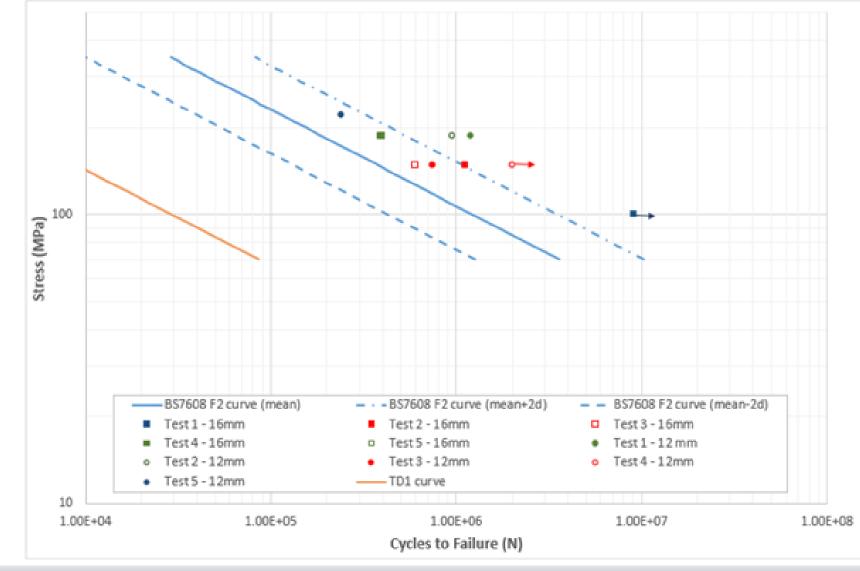
Welds without defects – Strathclyde (F2)

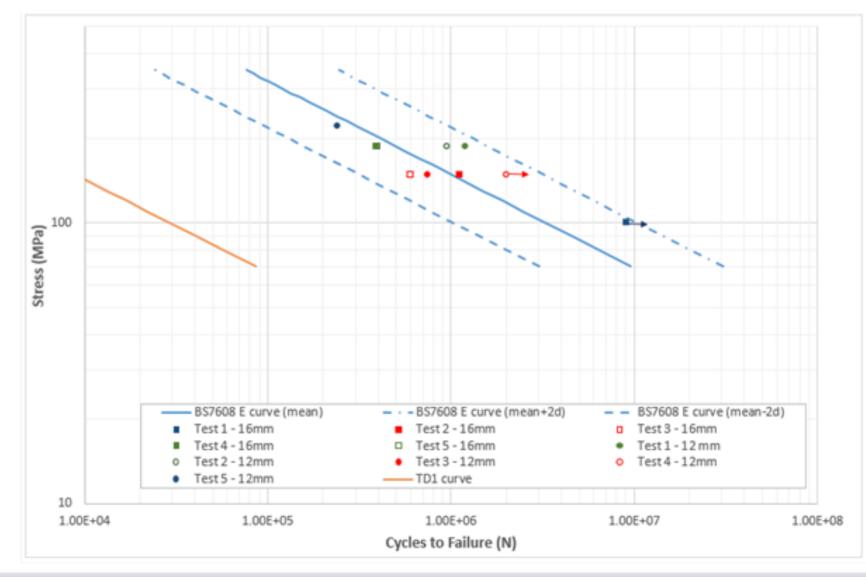
Welds without defects – Strathclyde (E)
