## **Characterization and assessment of laminations**

CONCAWE - OPMG

Brussels - April 2014

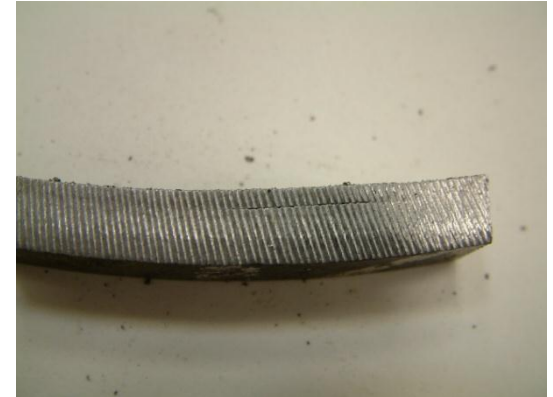
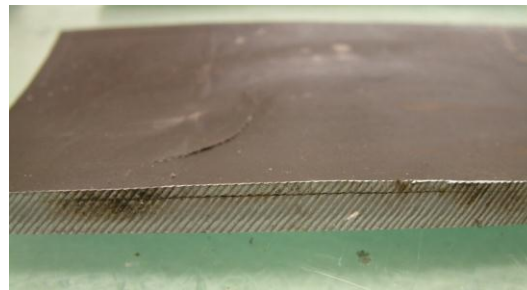
- A lamination is a discontinuity in the pipe material caused by:
  - Concentration of non-metallic caused by rolling-out of inclusions
  - Blow holes
  - Ingot cracks in parent material
- Characterization:
  - Parallel
  - Inclined
    - Closed
    - Open to internal wall
    - Open to external wall
