COPEX, 2014, Brussels ILI and CP Data Comparison and Usage

David Eyre, Penspen, UK

3rd April, 2014

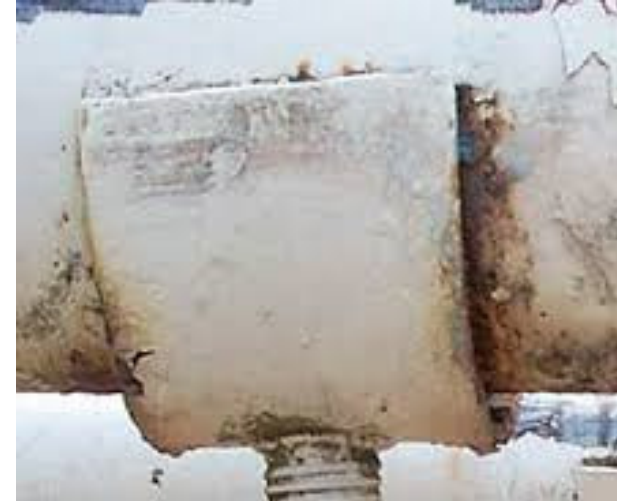
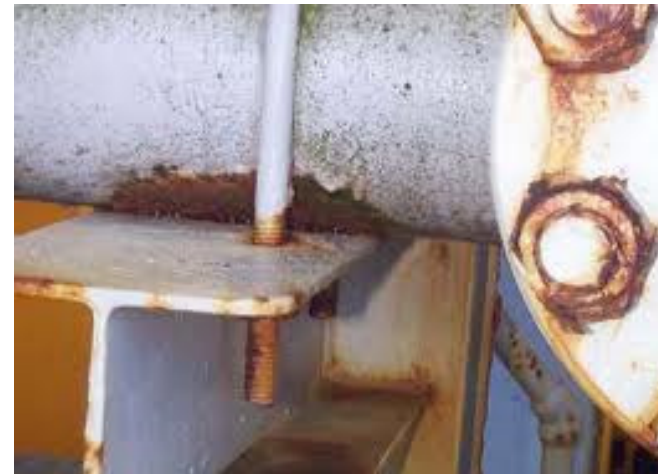
Above Ground Sections

- Corrosion under pipe supports where access is not easy.
- Corrosion rate 0.12 – 0.38 mm/yr
- Typical corrosion rate under pipe supports in coastal environment.
- Water and soluble salts can be retained in the crevice between the pipe and support.

- Move and recoat under pipe supports
- Verification digs
- CIP Survey needed
- CP needs adjustment
- OFF potentials should be routine

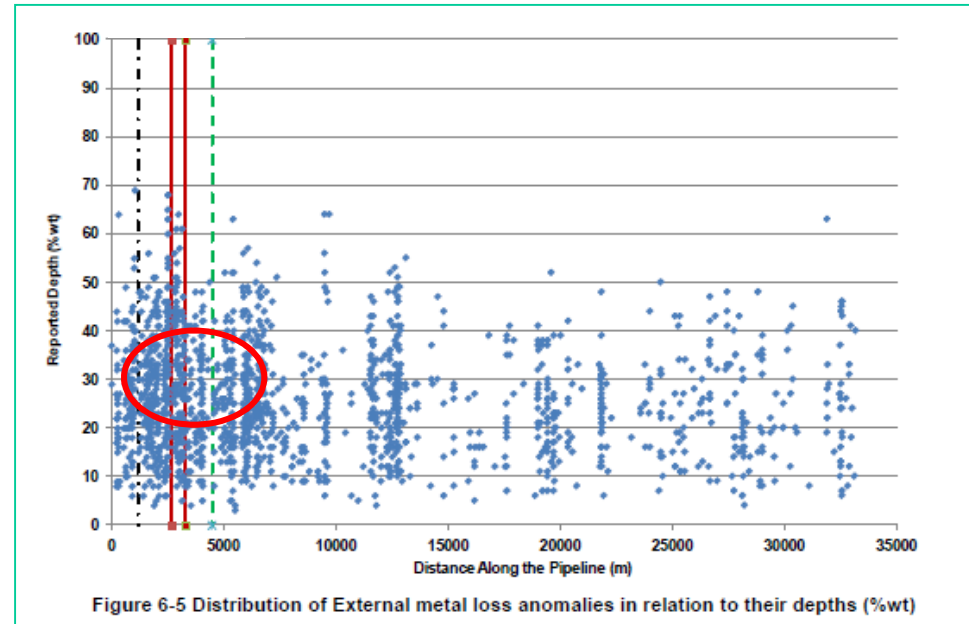
Field Joint Coating

- Concentration of external corrosion features at field joints
- Field joint coated hand applied hot enamel
- Still significant number of defects elsewhere

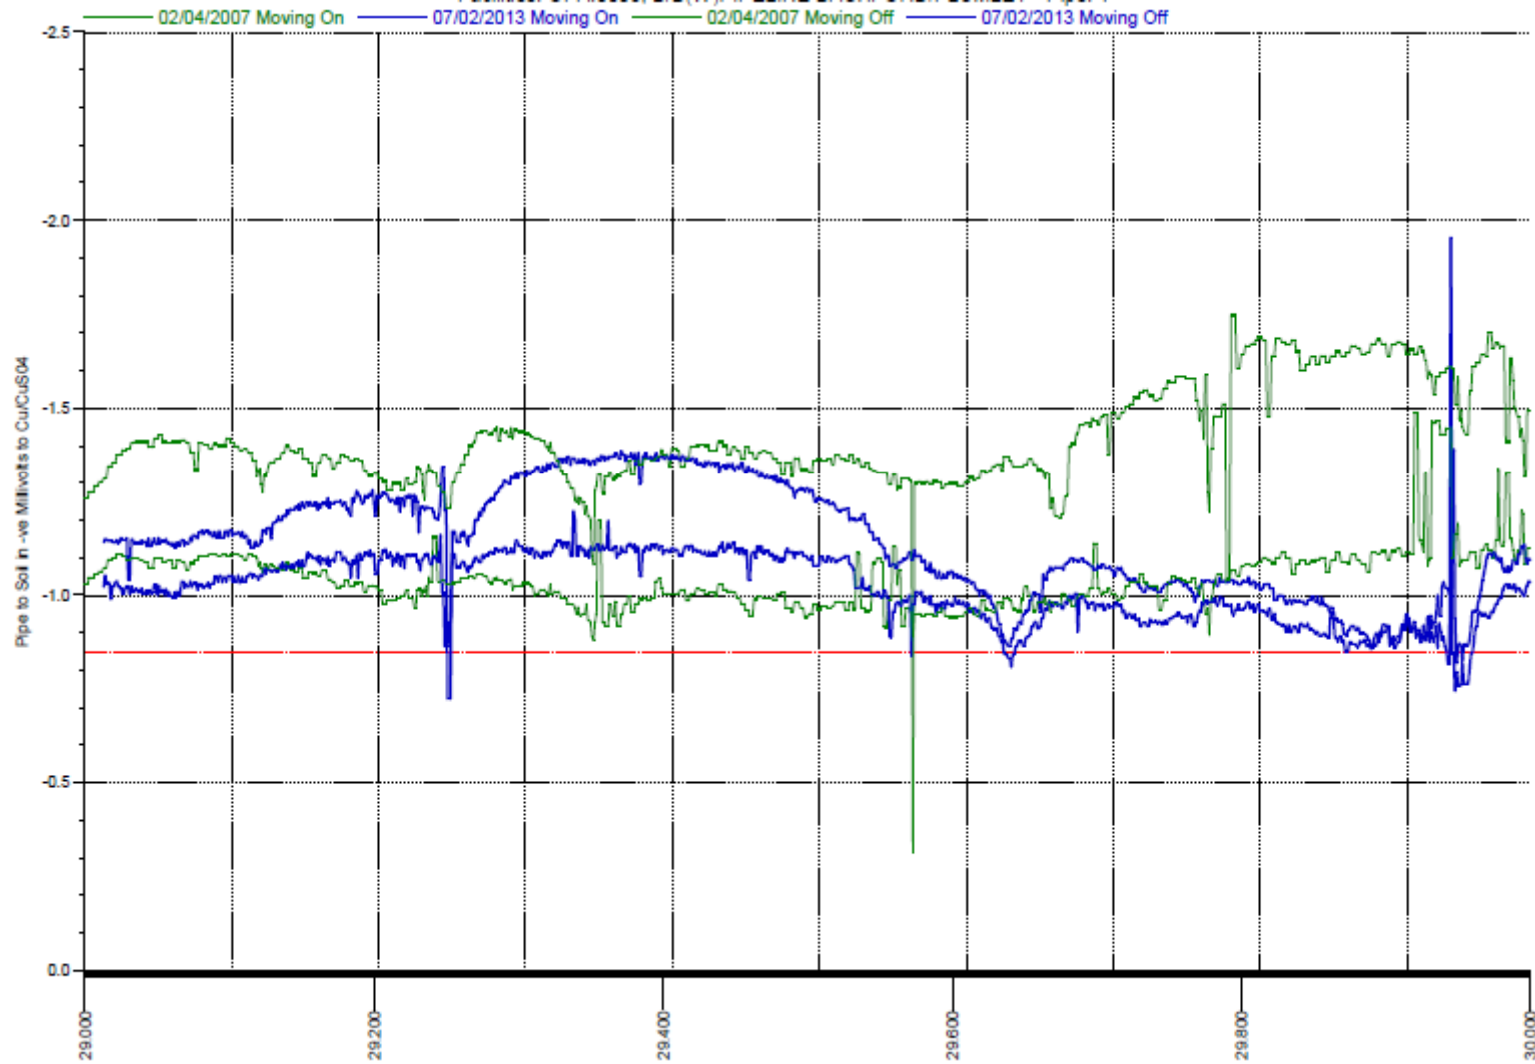
CIPS Data 2007 and 2013

- Verification digs found coating contained coke particles
- Coke forms a galvanic couple with the steel causing high corrosion rates
- -850 mV not enough
- -950 mV not enough

- Coating coked during application
- Potential criterion used inappropriate
- Restoration of CP Station current capacity ++ a priority
