Ground conditions above cross country pipelines change, reducing protection to the pipeline

MANAGING PIPELINES WITH REDUCED DEPTH OF COVER

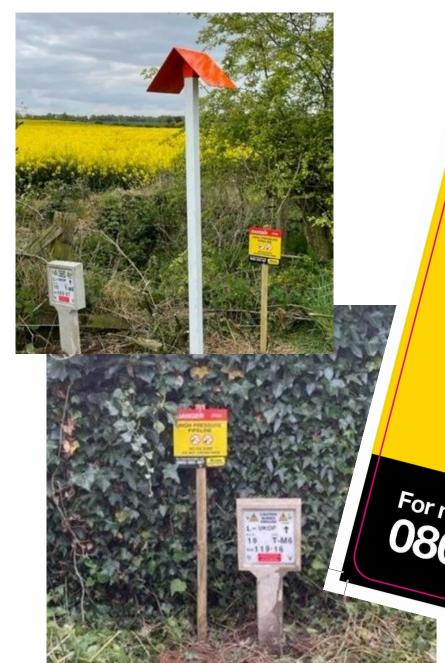
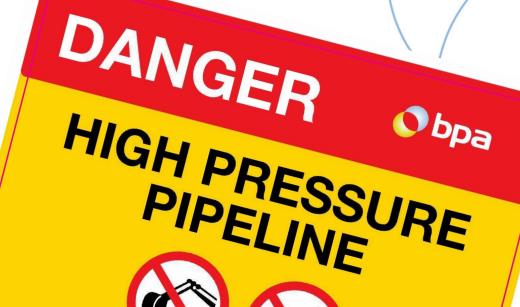
NO DIG ZONE
DO NOT CROSS HERE

Marker posts installed on high risk locations
Highest ranked locations: engineered protection installed

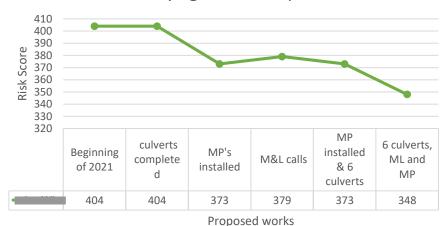
Expected risk scores for pipeline C when varying works take place in 2021

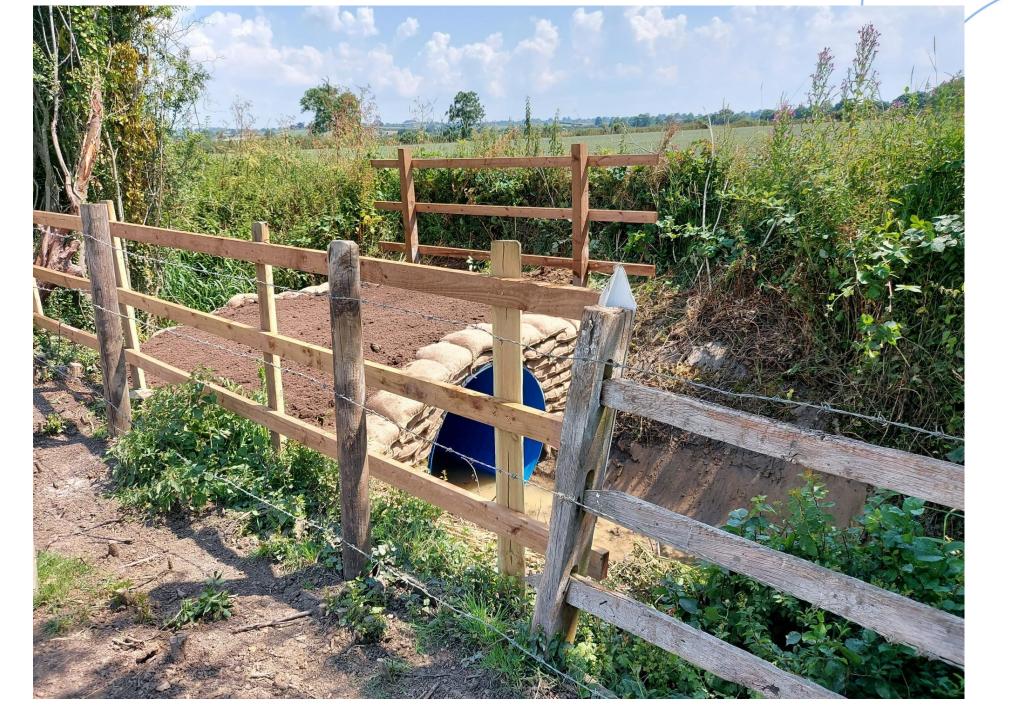
Depth: 100mm

• Length of Issue: 5 metres

Use – Designated River

Compromise – Fencing & Continued monitoring and liaison
