OPERATIONAL TRIAL OF DISTRIBUTED ACOUSTIC SENSING

COPEX 2022, GÜNTER BULAU

DAS - distributed acoustic sensing

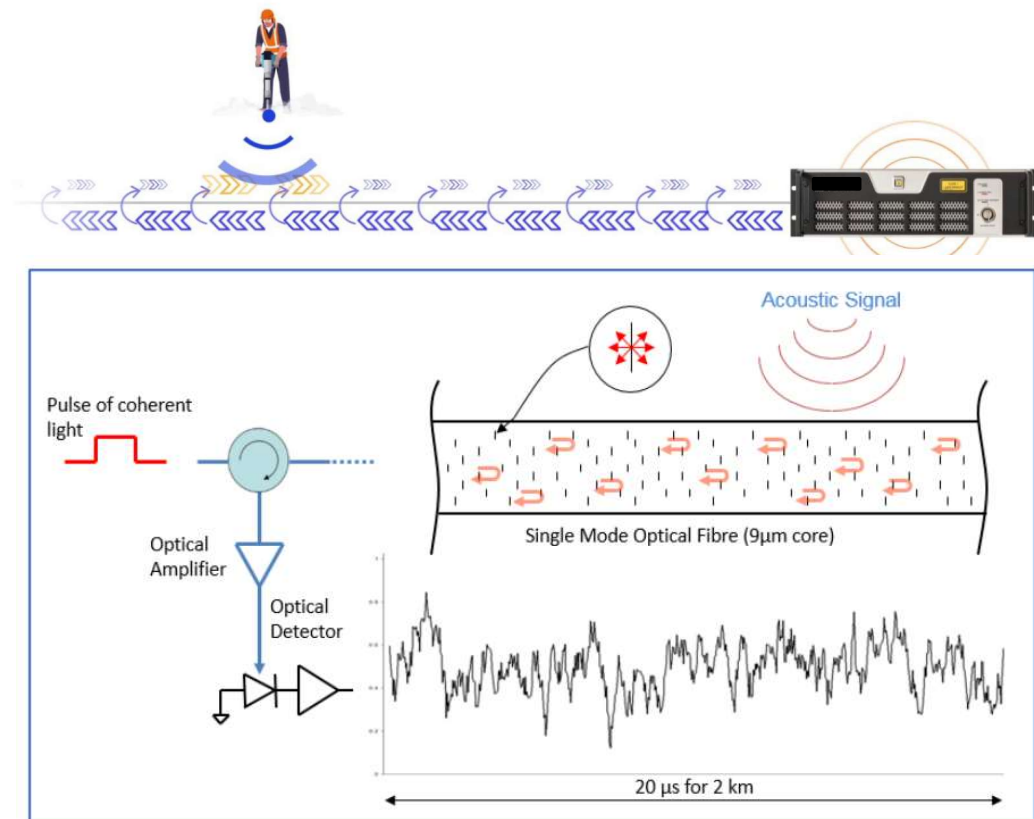
Principle of DAS, detection

- Laser pulse (thousands per second) is fed into the fiber optic cable
- Microscopic fractures in the glass of fiber
- Backscattering (Rayleigh)
- Microscopic motion is enough to change the relative position of the fractures
- Changed reflection is analyzed and evaluated
- Algorithms decide whether an alarm should be displayed

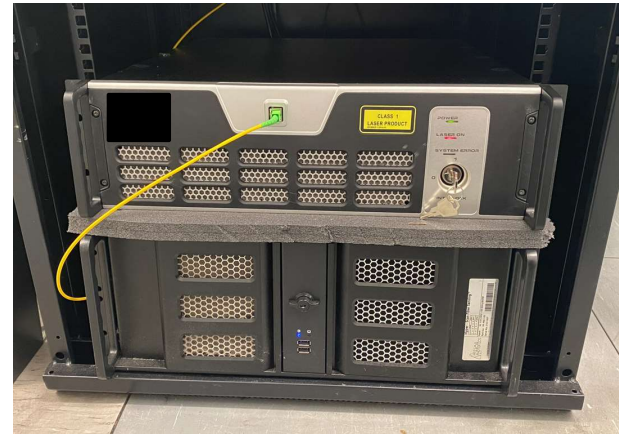
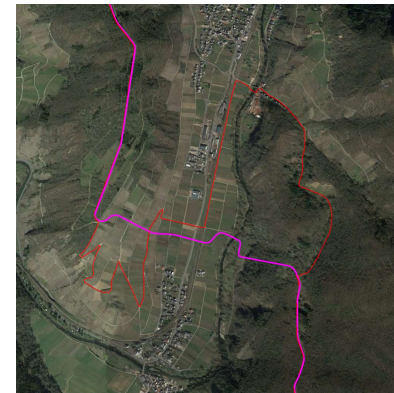
Installation

- ❑ Simple (plug and play)
- ❑ 19" rack (8u)
- ❑ Testing the optical link
- ❑ Synchronization
- ❑ Matching optical distance (fiber/pipeline)

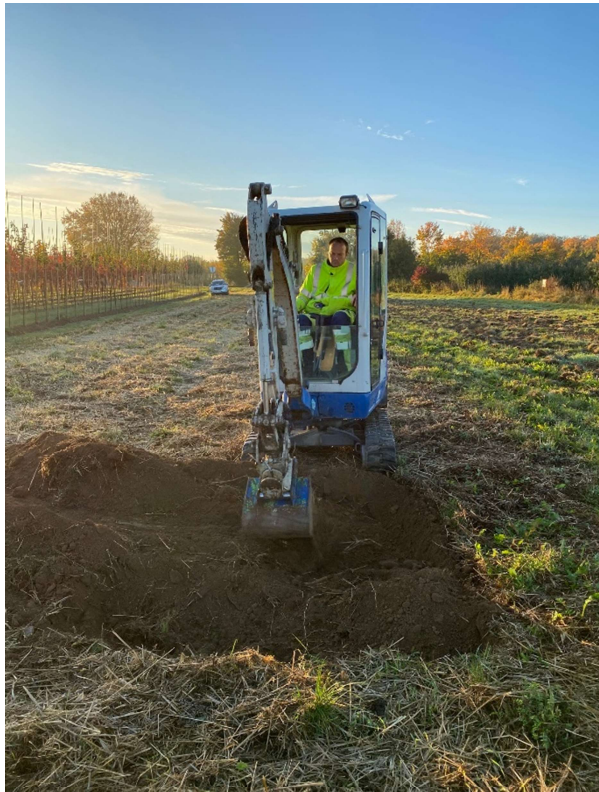
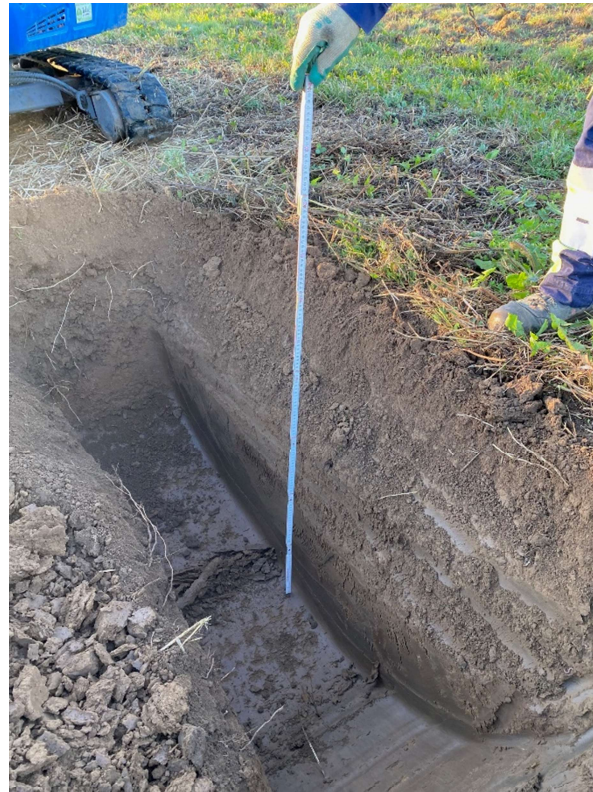
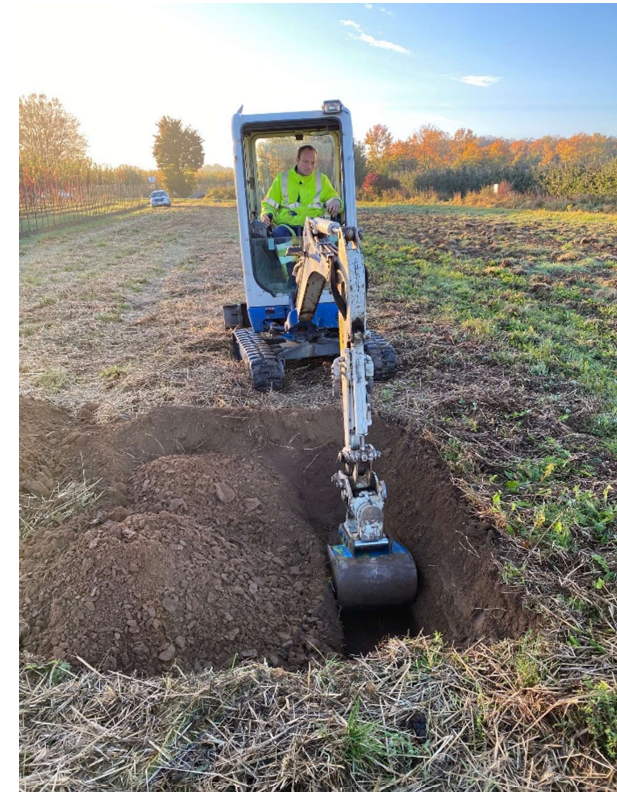
Test: 2x excavator work for minimum 15 minutes

08:26-08:38 above fiber
08:41-08:59 above pipeline

provider 1 no detection provider 2 no detection
provider 1 no detection provider 2 no detection

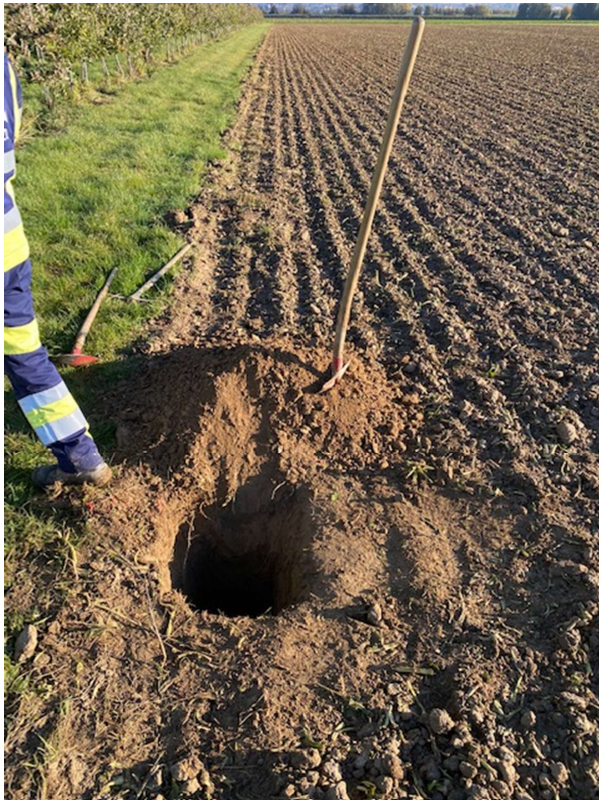
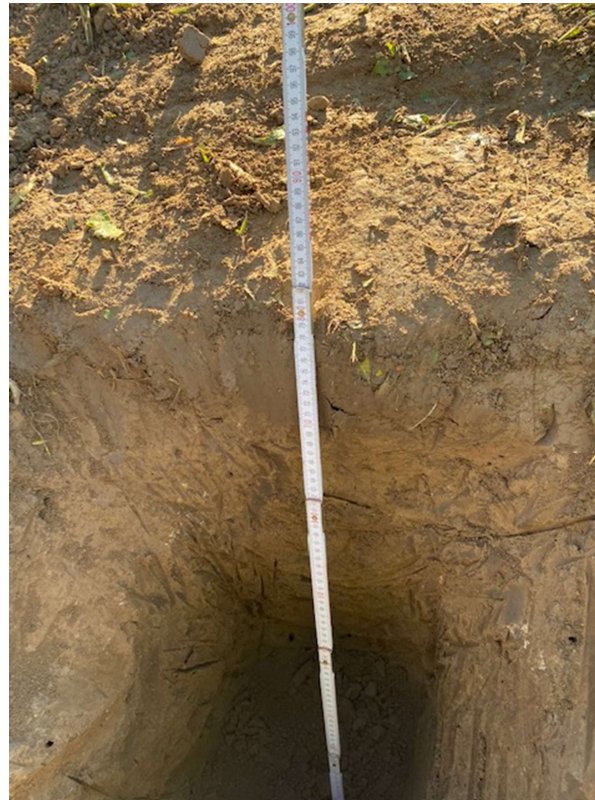
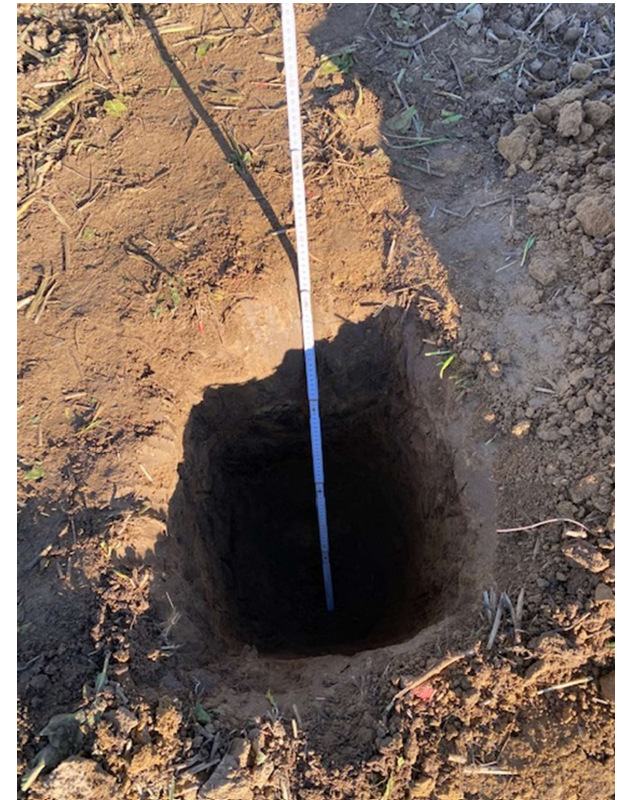
Test: 2x manual digging for minimum 15 minutes

09:40-09:57 above fiber

provider 1 Detected, accuracy + 20m provider 2 no detection

10:03-10:18 above pipeline

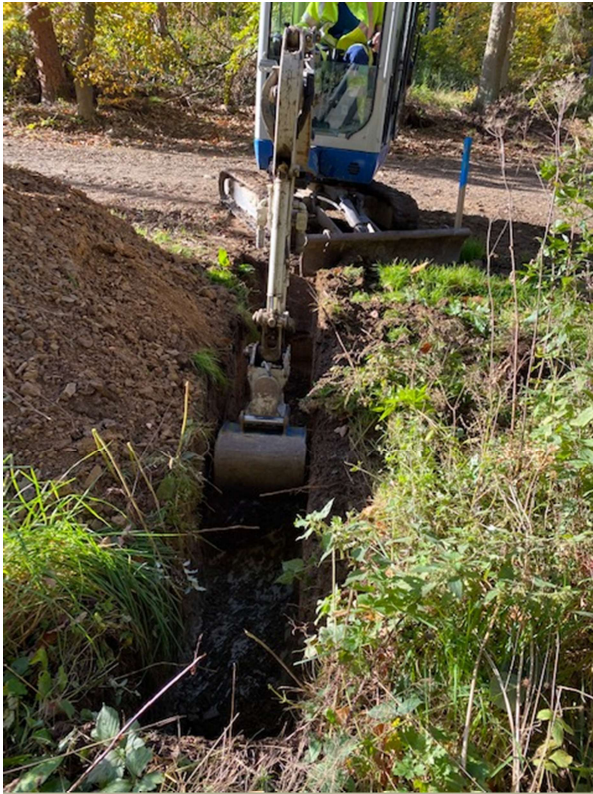
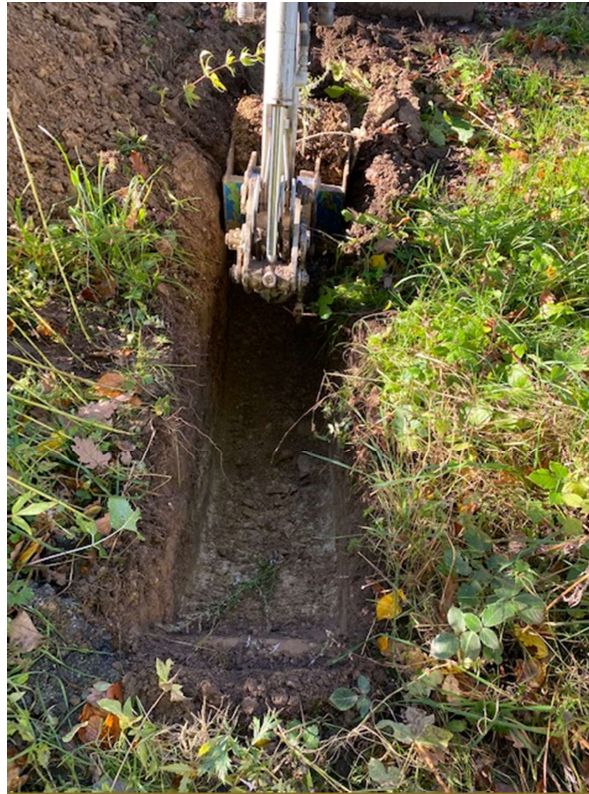
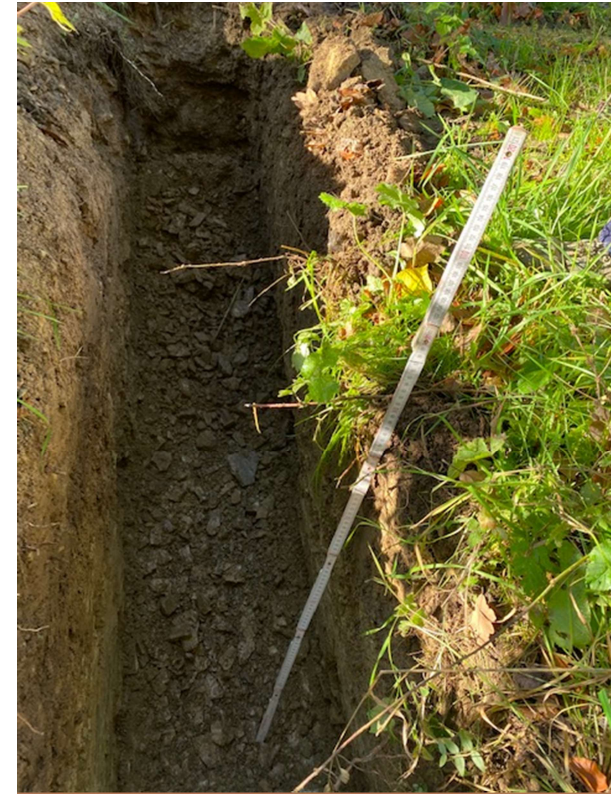
Test: 2x excavator work for minimum 15 minutes

Around 11:00 above fiber both providers **no detection**
Around 11:30 above pipeline provider 1 **no detection** provider 2 **detection** (accuracy 400 m)

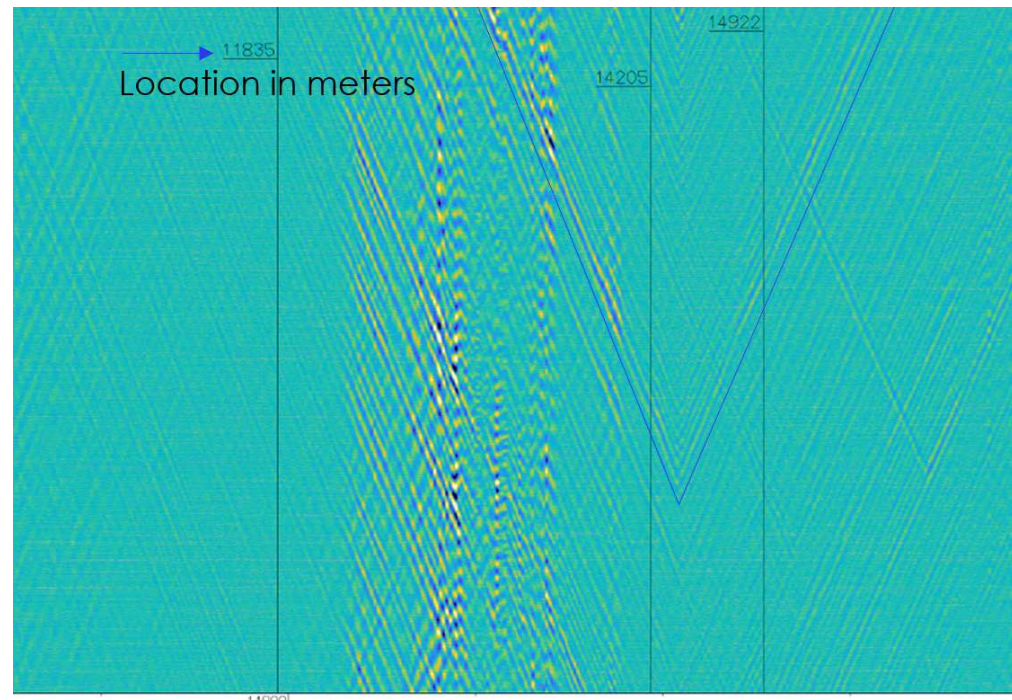
Pig detection

- „triangle signal phenomena“ identified as spheres

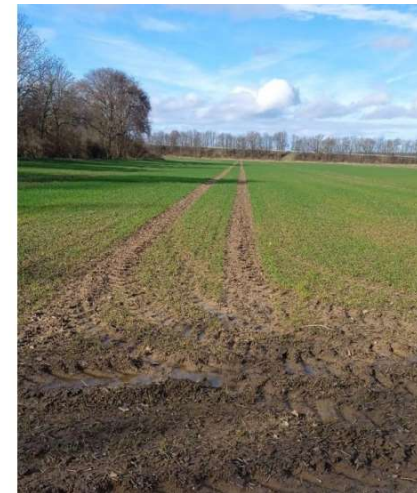
- Date: 14/02/22
- Time of arrival: 12:15
- Alert type: Mechanical digging
- Range in meters: 27350
- Description: Agriculture field tilling
- Conclusion: Suspected as NAR

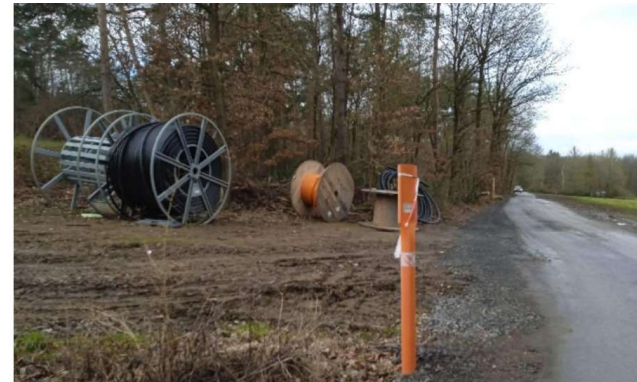
- Date:15/02/22
- Time of arrival:11:20
- Alert type: Mechanical digging
- Range in meters:44000
- Description: Drifting PE pipeline installation
- Conclusion: Suspected as NAR

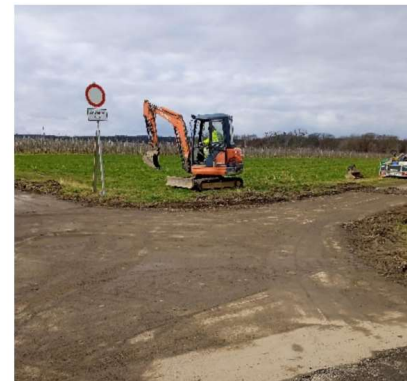
- Date:15/02/22
- Time of arrival: 12:55
- Alert type: Mechanical digging
- Range in meters:36667
- Description: Excavator working
- Conclusion: Real activity

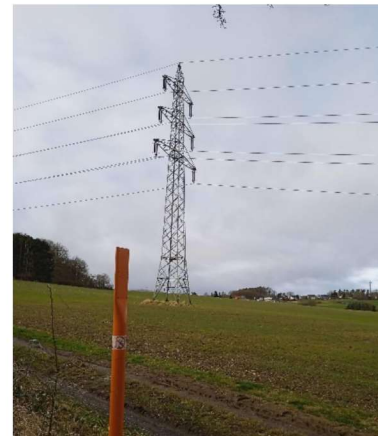
- Date:16/02/22
- Time of arrival: 11:51
- Alert type: Mechanical digging
- Range in meters:42720
- Description: Electric pole might vibrate strongly by a wind burst
- Conclusion: Suspected as NAR

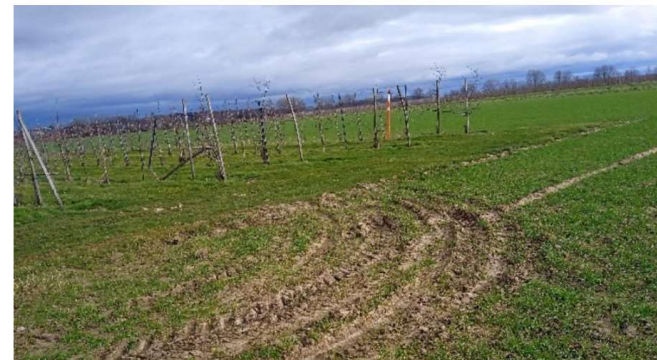
- Date: 16/02/22
- Time of arrival: 12:37
- Alert type: Mechanical digging
- Range in meters: 33865
- Description: Agriculture tilling
- Conclusion: Suspected as NAR

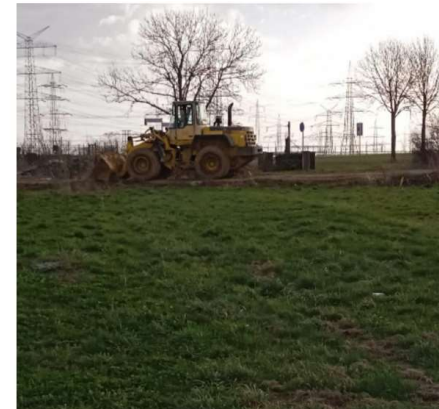
- Date:17/02/22
- Time of arrival: 11:53
- Alert type: Mechanical digging
- Range in meters:4760
- Description: real activity, about 100 meters from the pipeline as a result suspected as NAR
- Conclusion: Suspected as NAR

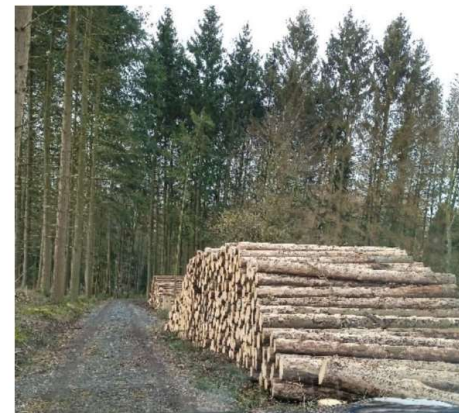
- Date:16/02/22
- Time of arrival: 11:04
- Alert type: Manual digging
- Range in meters:52230
- Description: Woodwork
- Conclusion: Suspected as NAR

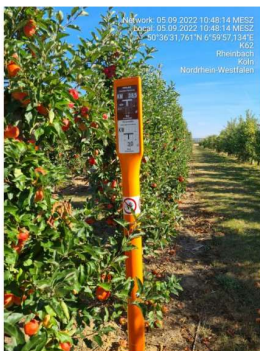
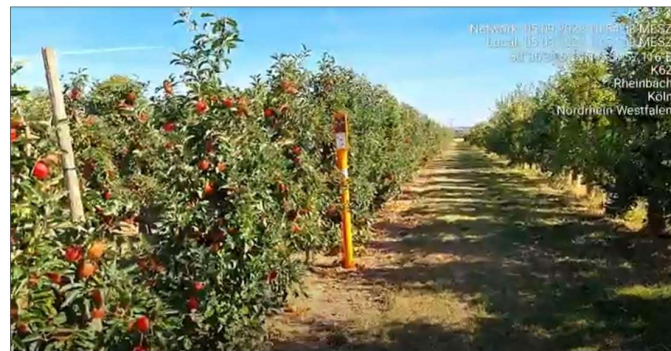
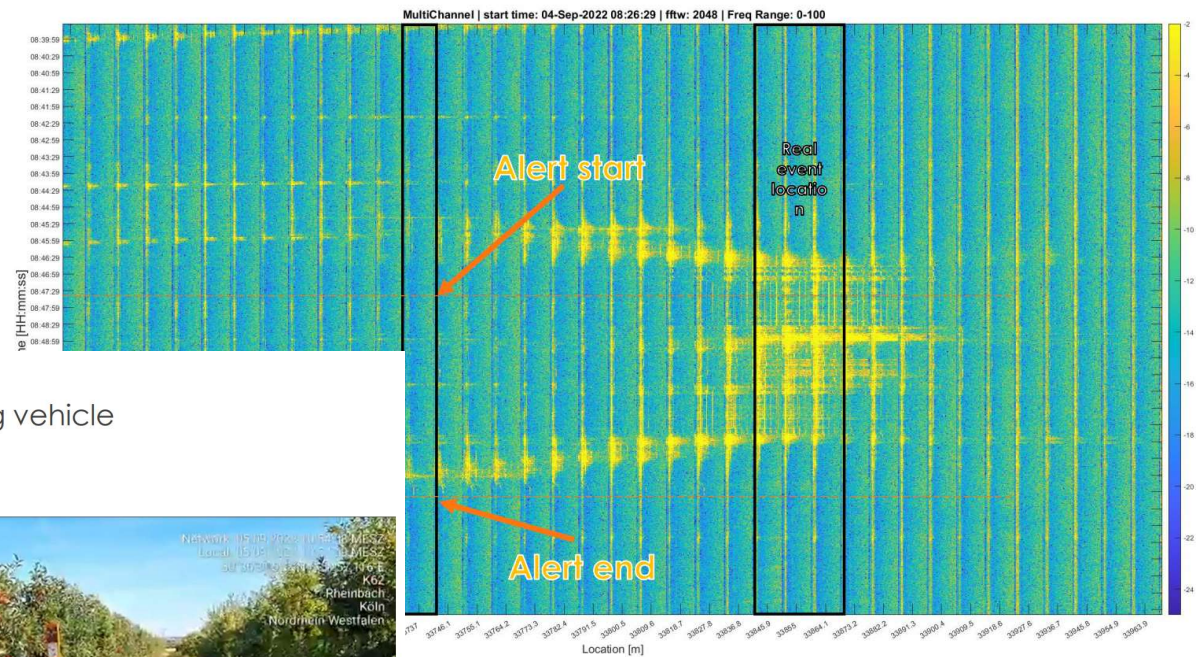
Events as signals

This event shows a quite area, arrival of a vehicle, mechanical signals with impulses signal in the beginning, middle and end before vehicle leaves the area.

- Apple plantation
- This alert was caused by the harvesting vehicle loading boxes. A very active location

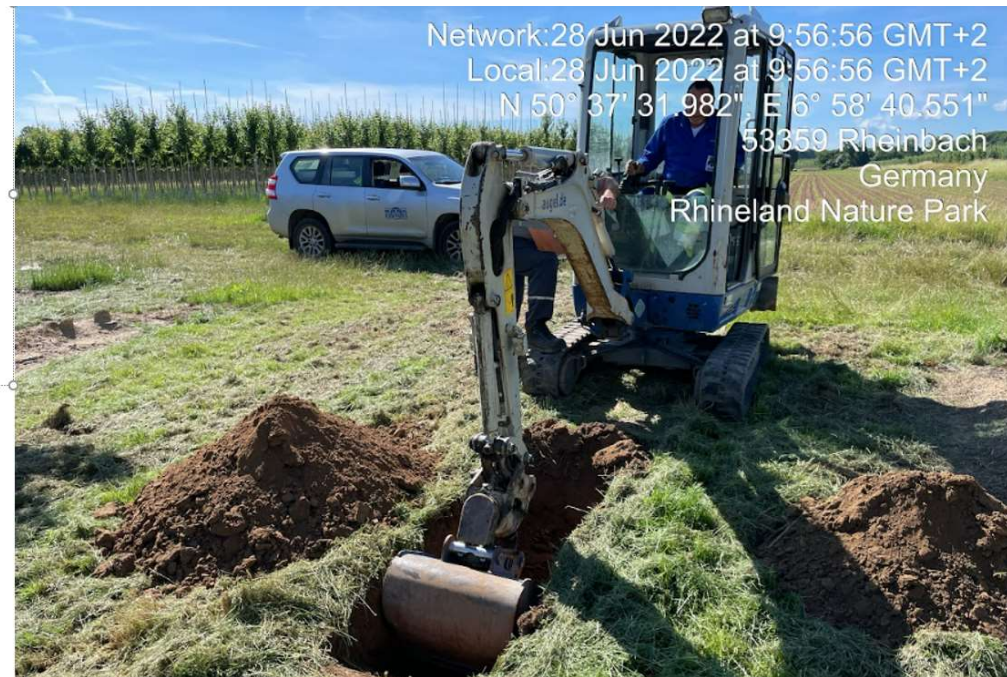
- Excavator work for 10 minutes
- Time: 09:49 – 09:59
- Location: 50.6252 6.9782
- **Detected** - ID 99.594734
- Alert was combined with the following manual digging test due to system bug that was fixed.

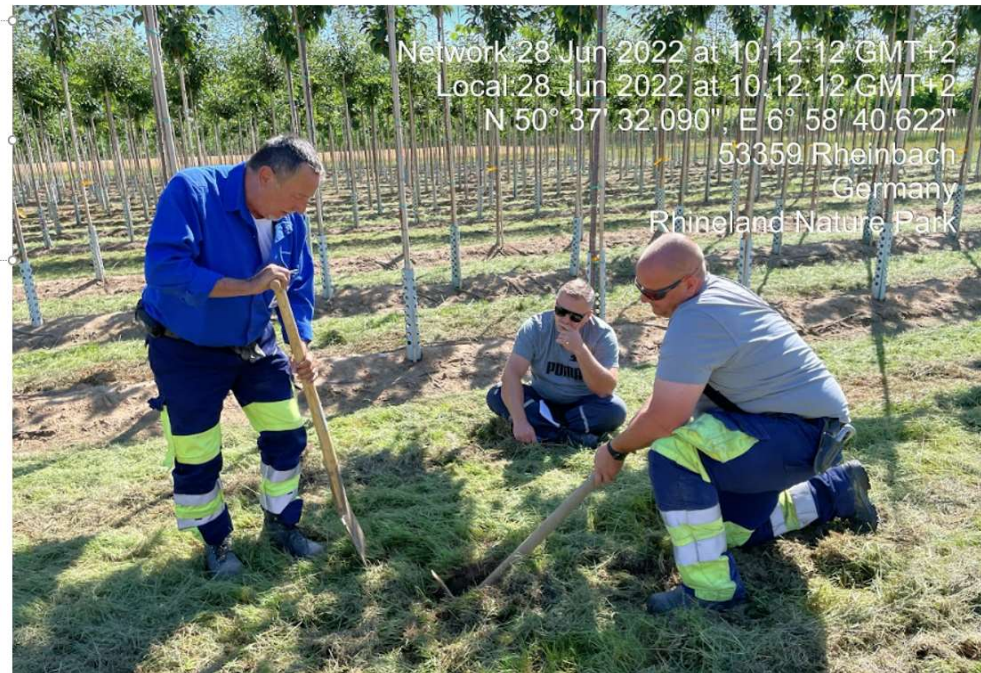
- Manual digging for 6 minutes
- Time: 10:08 – 10:14
- Location: 50.6252 6.9782
- **Detected** | ID 99.594734

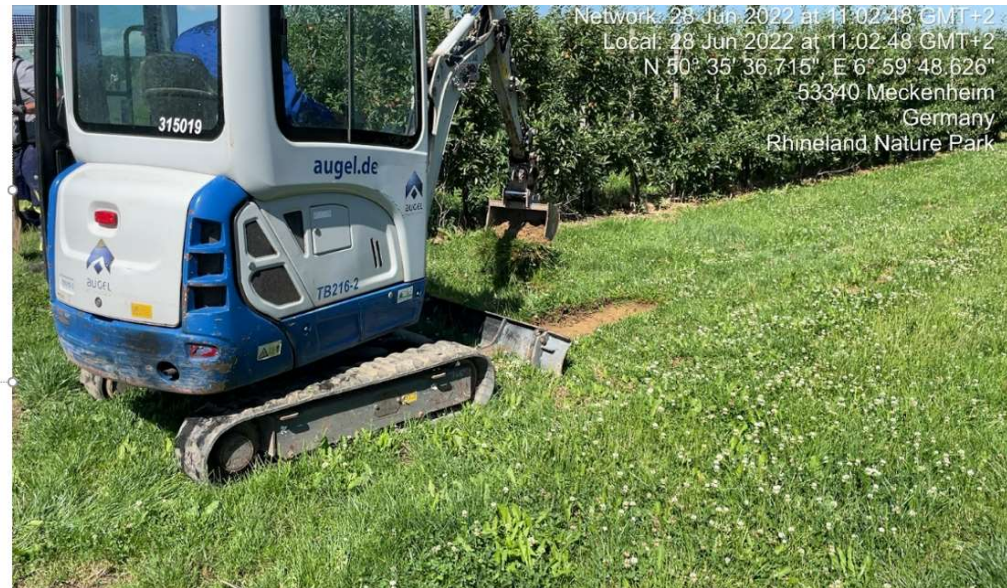
- Excavator work for 10 minutes
- Time: 11:02 – 11:12
- Location: 50.5937 6.9966
- **Detected** - ID09-85.9120
- Alert time includes covering the hole and manual digging which came right after that, due to a very short break between events.
